*Preservation Maintenance
Plan Report for the
Clinton County Historical
Society/Rombach Place
Carriage House*

Project No. 24-100901.002

Preservation Maintenance Plan Report Clinton County Historical Society/Rombach Place Carriage House

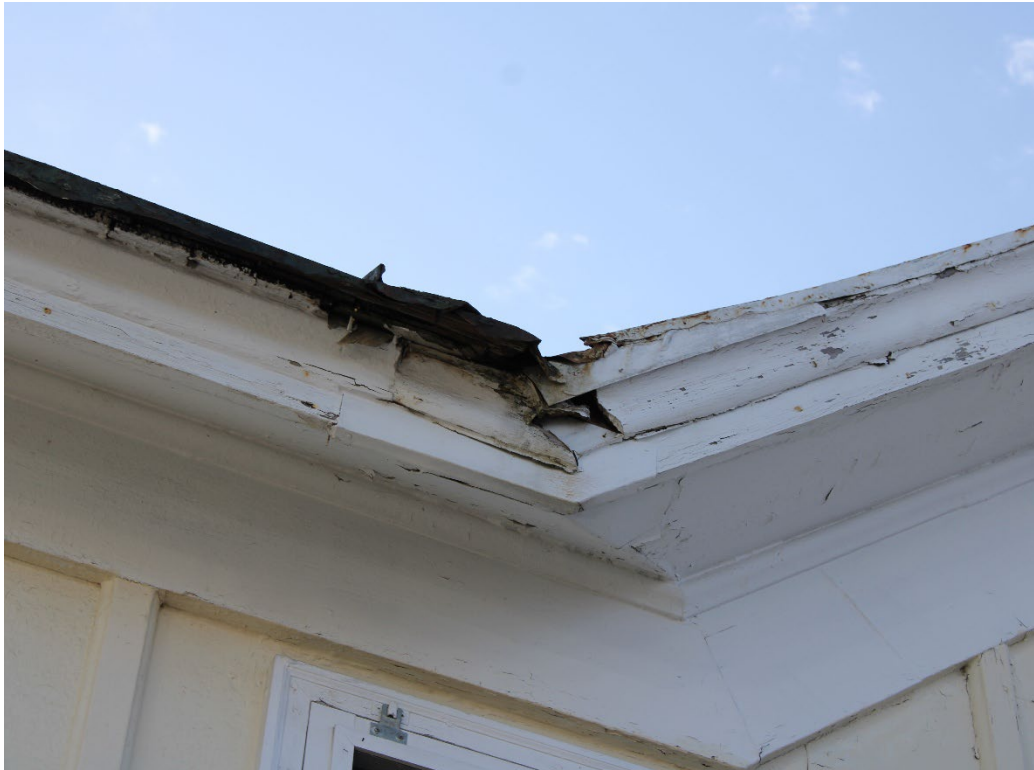
The Rombach Place Carriage house's existing roof is comprised of terne metal and is currently in good condition aside from a few small issues identified during the survey. Field survey identified several areas of rust, discoloration, and failing seams. At the junction of all four hips-and-valleys, the metal roof ends show cracks, breaking, and rust, consistent with persistent water damage because of the lack of proper stormwater management (Figure 4-2).

Figure 4-2. Example of the water damage seen on the terne metal roof, facing NE 2024.

The Carriage House roof has several areas of rust and broken joints. These issues likely arose due to the failure of the current coat of paint, which was applied c. 2000. The General Services Administration provides guidance on the recommended steps and procedures for the repair of terneplate roofing, the steps are briefly laid out below (General Services Administration 2016).

- The current roof should be stripped of paint using a chemical paint stripper and cleaned using a chemical cleaner, and the failed joints should be re-soldered.
- Where extant, rust should be removed using the most minimal means necessary.
- For rust-outs, repair should be undertaken by soldering the same kind of metal over the damaged area
- Following the repair of all rust and other damage, the entire roof should be repainted with a red iron oxide and linseed oil-based paint specifically formulated for use on terne metal roofs.

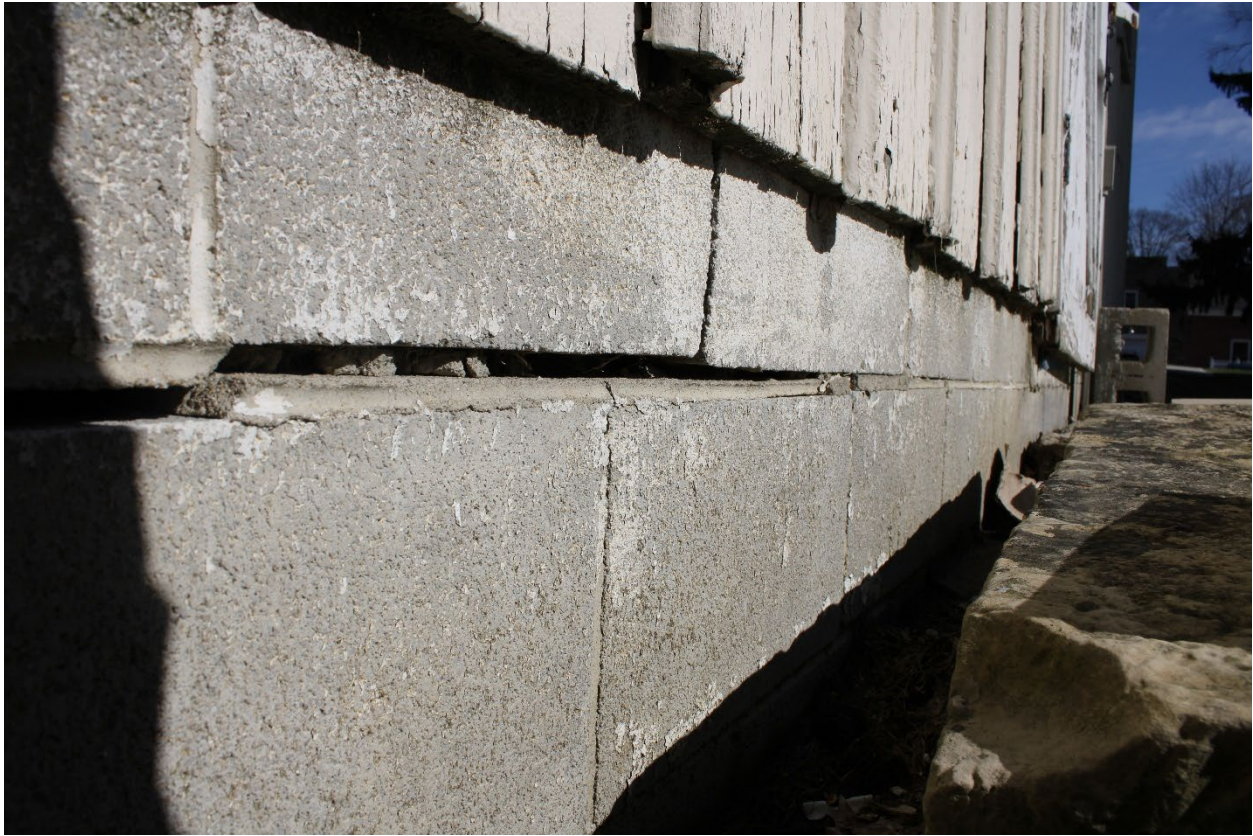
Field observations revealed several problems with the Carriage House foundation. The most critical of these foundation issues observed is the shifting of a series of concrete blocks located on the central bay of the main façade. The blocks are bowing outward from the rest of the building and also contain a hairline crack (Figure 4-3).

Figure 4-3. Overview of bowing/bulging foundation blocks. 2025

- Repoint areas where mortar is missing, failing, or where has been replaced with caulking.
 - Existing caulking should be removed from the joints and replaced with a Type S mortar, which is higher strength, appropriate for use with concrete masonry units.
- Monitor bowing concrete masonry units.
 - As the bowing/bulging of the concrete masonry units is minimal, attempts should be made to monitor the bowing/bulging blocks. Common monitoring methods

include routine measurement of the cracks, documenting the frequency and size of the changes.

- If further movement is noted, a structural engineer should be consulted to prevent further damage or structural failure.

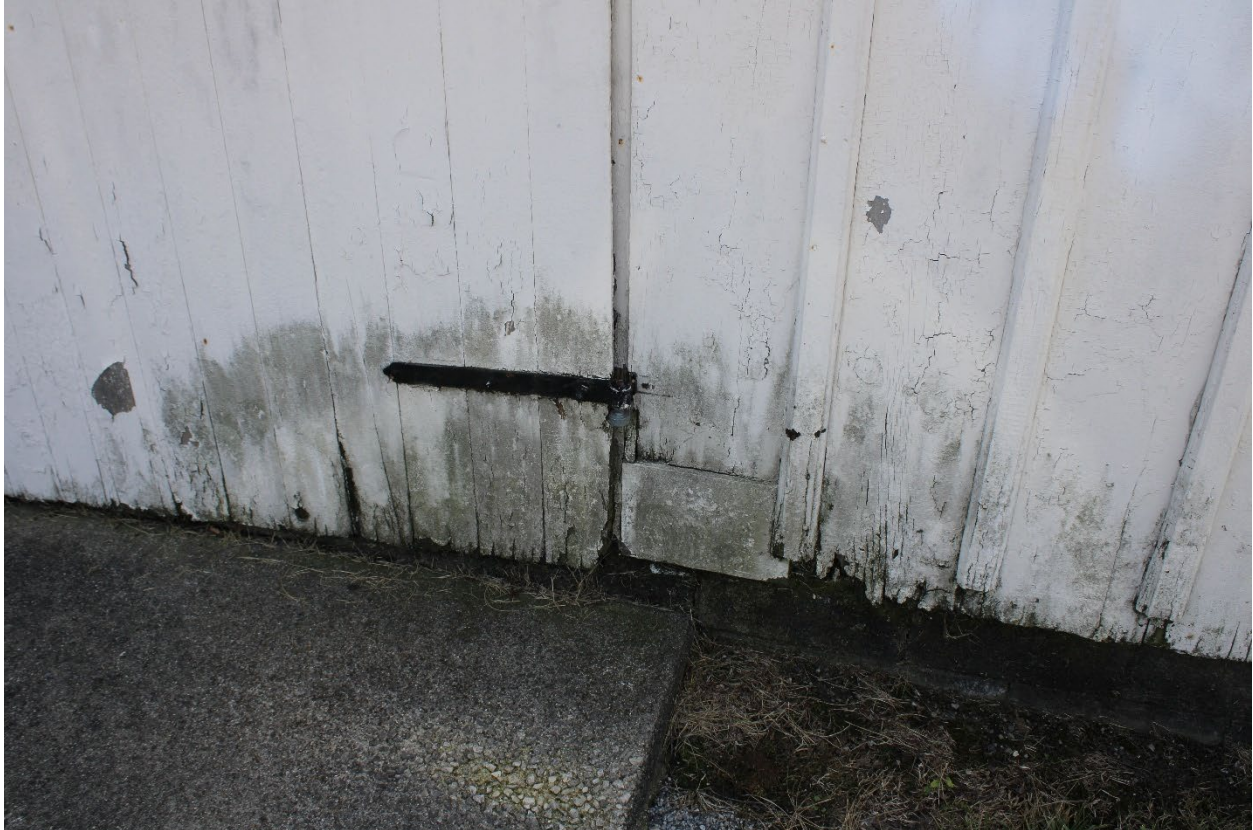
The northern set of doors has extensive wood rot and moisture related paint damage present on the bottoms of both doors. Additionally, the weight of the doors on the pairs of hinges, combined with wood rot on the surrounding structural elements of the door, is creating a disconcerting lean to the door, with the likely result of the separation of the hinges and doors from the surrounding door framing (Figure 4-4). The damage is most evident on the right-hand door with severe discoloration and rot. CCHS Staff revealed that the door is functionally compromised and about to break off from the supporting framing. (Figure 4-4).

Figure 4-4. Photo showing extensive wood rot on the double doors at the north façade, 2025

- While not specific to doors, Preservation Brief #9 provides information on the repair and restoration of historic wood that applies to doors as well and can be referenced for water and rot damage (Myers 1981).
- Repair of rotted wood
 - Where possible, in-place repairs should be attempted first, with either a wood dutchman, or a two-part structural epoxy, in conjunction with a wood consolidant that regenerates and waterproofs rotted wood. If repairs is not an option, rotted wood should be removed and replaced using the same species of wood.
 - LiquidWood and WoodEpoxy, by Abatron are two products suggested. Similar products do exist from other companies.
 - Strip and repaint damaged paint
 - Where the paint has visibly failed through cracking, peeling, crazing, or bubbling, it should be removed and replaced with an oil-based primer and at least two coats of exterior grade paint.

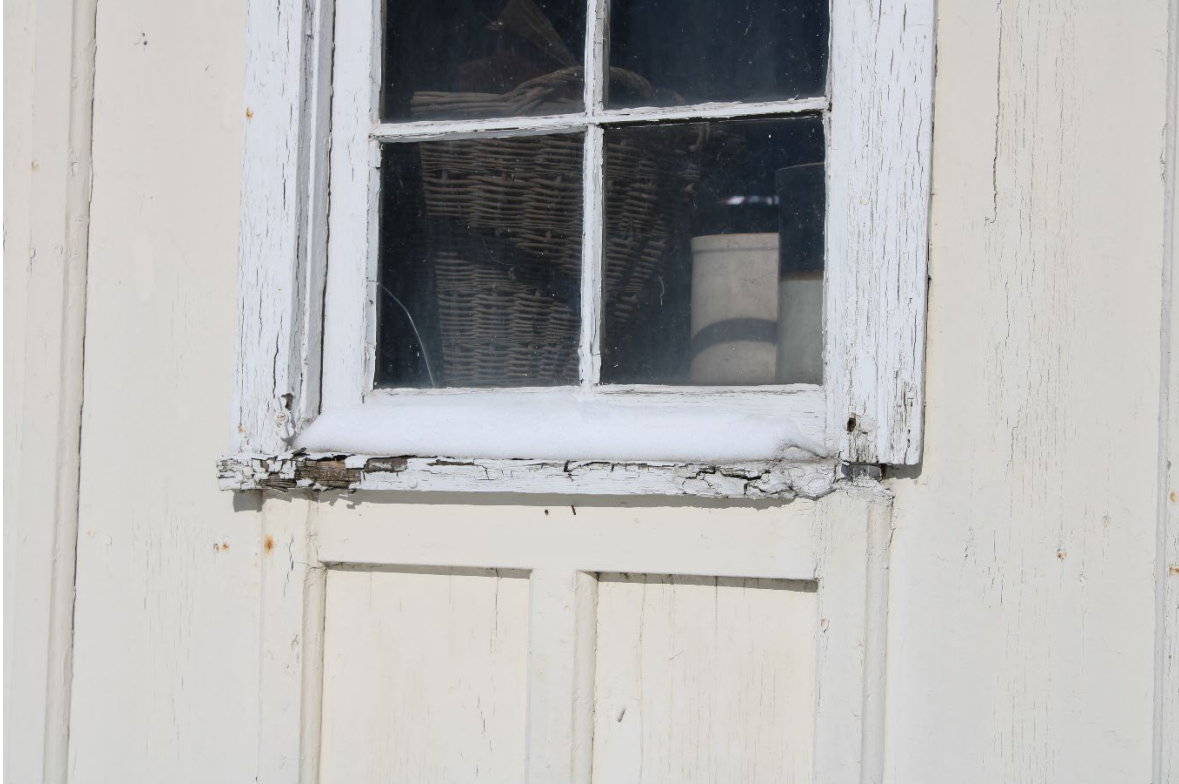
The Carriage House has a total of 18 windows, all of which appear to be original to the building and are of wood construction. The window sashes are generally in good condition. However, every window on the Carriage House shows spots of missing, flaking, or curling glazing putty. This is expected over time due to environmental factors, and routine replacement of all glazing putty is a part of cyclical maintenance. Several of the windows surveyed display evidence of interior moisture damage, but none are serious enough to warrant immediate attention. Many of the exterior window frames and casements show moisture related damage which has led to severe rotting of both the sills and lintels throughout the exterior of the building, these items should be repaired or replaced as needed (Figure 4-5).

Figure 4-5 Photo of moisture related damage, first floor window, central bay, main façade, facing NW, 2025

- All windows on the building need some amount of maintenance or repair. The following recommendations follow the guidance set forth in NPS Preservation Brief #9 “The Repair of Historic Wood Windows” (Myers 1981):
 - Restoration of damaged window sashes, casing, and trim
 - Where possible, rotted sashes, casing, and trim should be repaired in-place with either a wood dutchman, or a two-part structural epoxy product, in conjunction with a wood consolidant that regenerates and waterproofs rotted wood. If repair is not an option, the damaged wood should be removed and replaced using the same type of wood.
 - LiquidWood and WoodEpoxy, by Abatron are two products suggested. Similar products do exist from other companies.
 - Re-glaze windows where glazing putty is failing.
 - Glazing putty should be of a calcium carbonate and linseed oil composition. Sarco Dual-Glaze and Type-M, or similar.

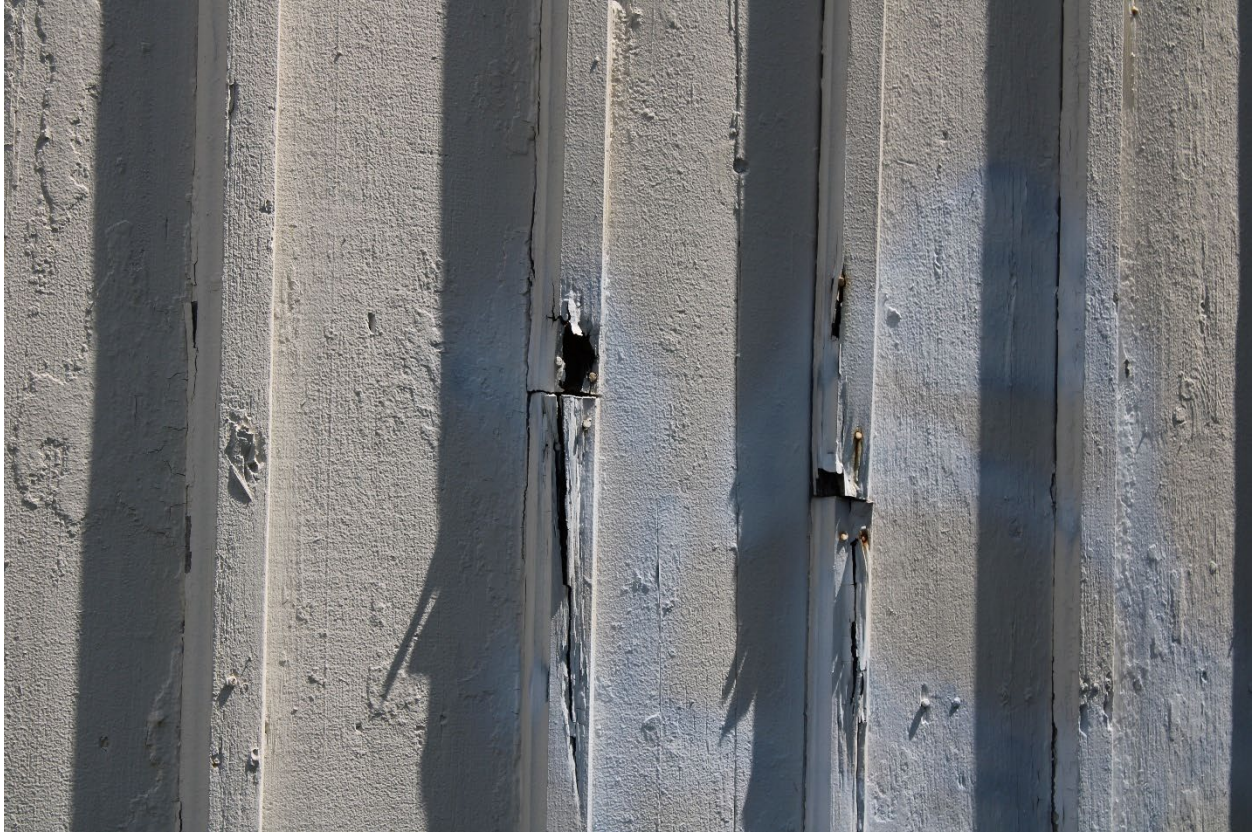
Other observed damage to the siding can be seen in the form of wood rot present on the side of the building leading to holes, most evident under the attempted graffiti removal on the northern and western elevations (Figure 4-6). In addition, inappropriate metal patches are present in two places on the building, on the main façade in between the windows on the central bay (Figure 4-7). A series of battens, most notably on the western elevation, appear to have a combination of moisture damage, and failing fasteners, leading to their separation from the boards underneath.

Figure 4-6 Example of wood siding rot and paint failure, western façade.

- Similar to damage on the windows and doors, care should be taken to first try and repair rotted/damaged siding pieces. In-place repairs with either a wood dutchman, or two-part structural epoxy products, in conjunction with a wood consolidant that regenerated, and waterproofs rotted wood should be prioritized
 - In cases where repair is not an option, siding should be replaced with a piece of wood of the same species as the original.
 - Complete strip and repaint of the siding
 - To further ensure the protection of the wood siding, a full strip and repaint should be done. Mechanical stripping methods, like scraping, and sanding, should be enough.
 - The wood should be first primed with an oil-based primer, then painted with at least two coats of an exterior grade paint.
- Interior Structure

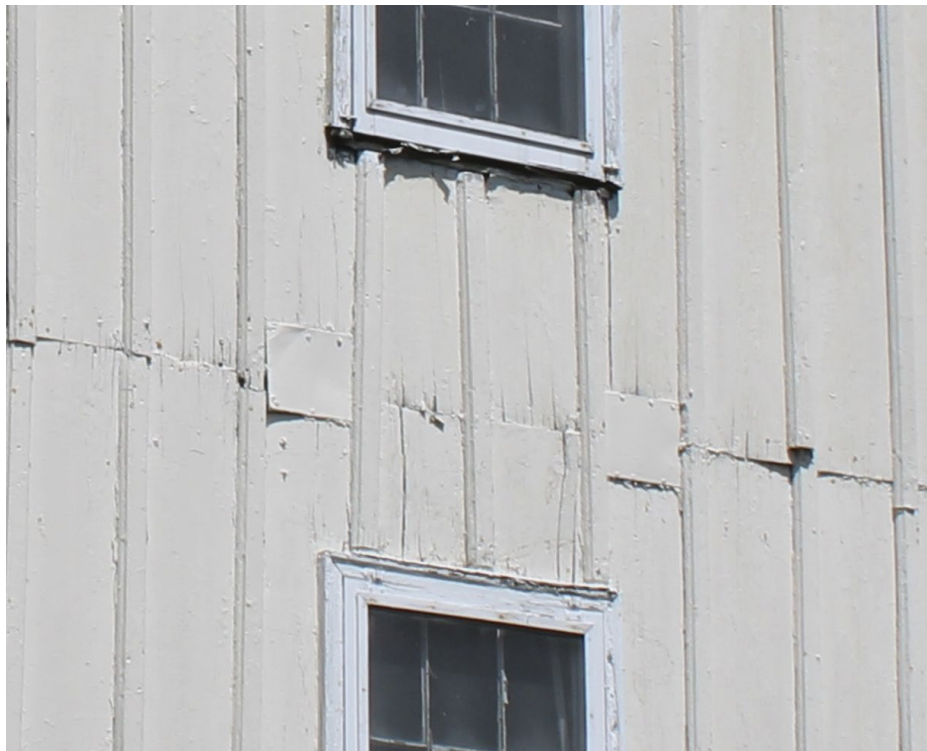
Figure 4-7 Inappropriate siding patches, south facade, 2025

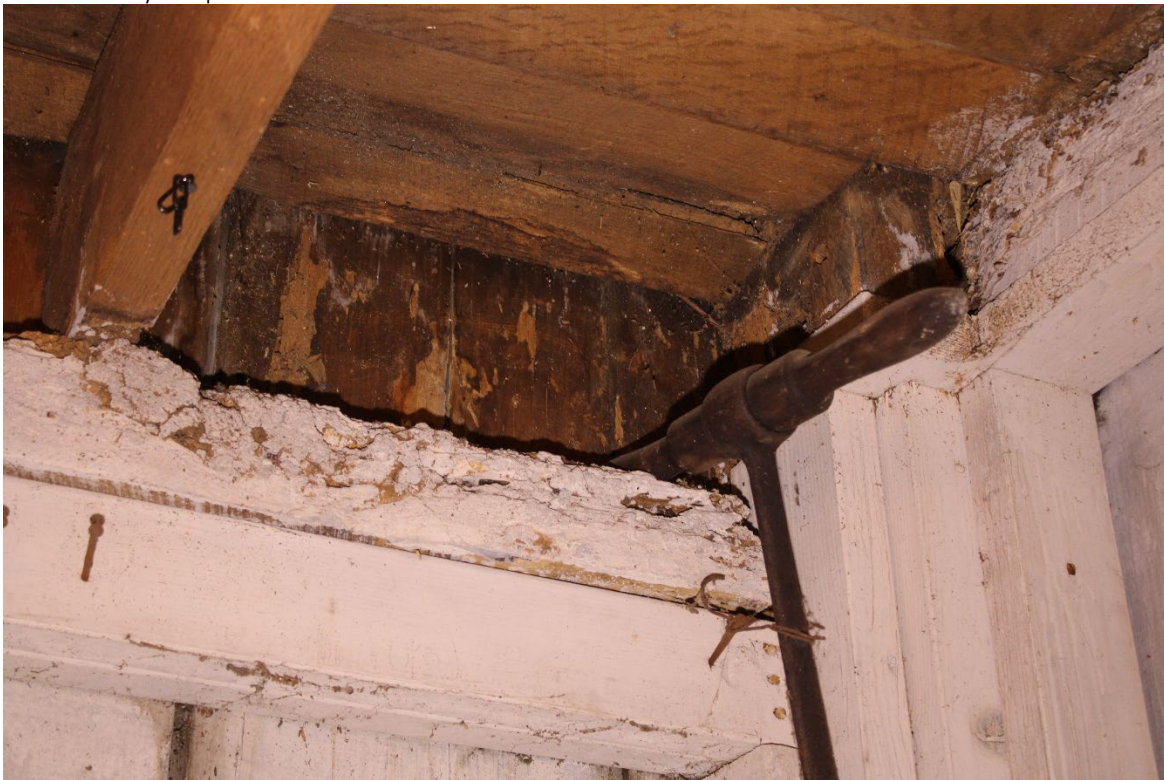
Figure 4-20. Overview of moisture damage on the eastern wall, 2025

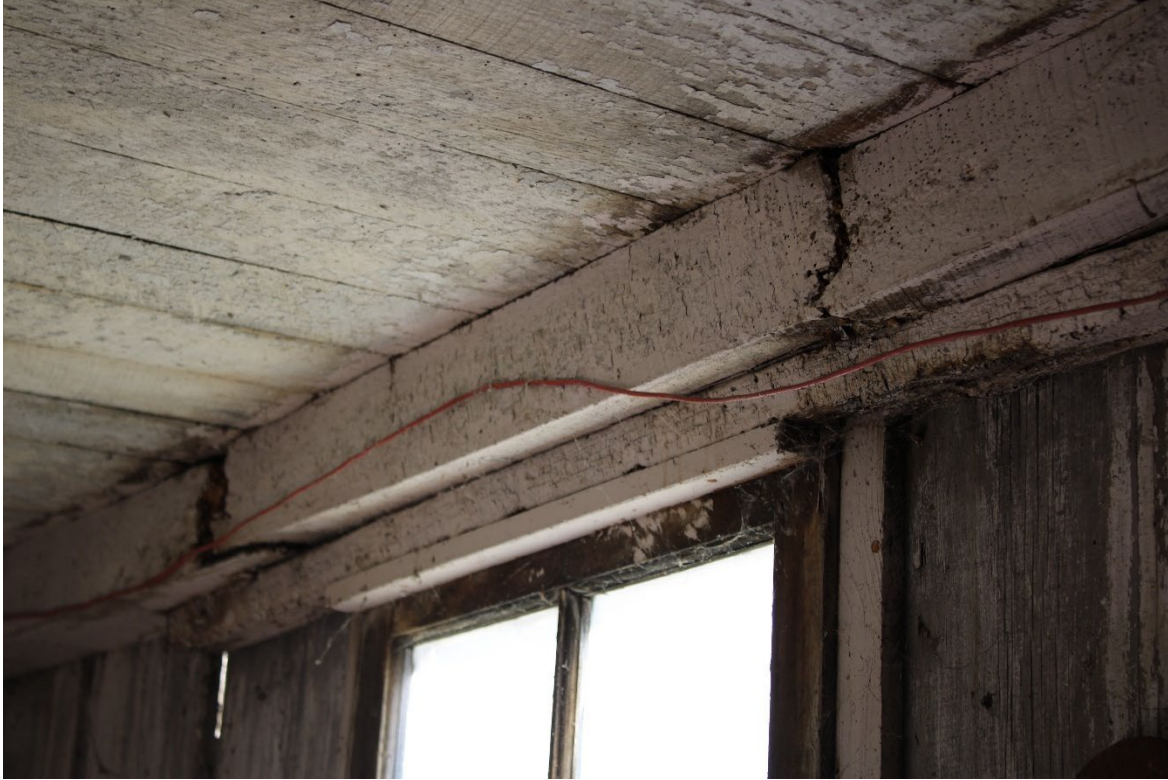
Field observations revealed that a structural beam that runs along the south side of the building has failed in two places, on either side of the central window, west of the main entry door (Figure 4-21). The failure has likely been present for some time, due to the inclusion of an additional piece of lumber directly underneath.

Figure 4-21. Overview of cracked support beam, 2025

- The cracked beam on the south wall should be cut out, past where any wood rot or damage may exist. The new piece should be inserted where the broken piece was taken out, with a half-lap joint, or similar method of construction, to ensure the load gets transferred to the new wood correctly. Additionally, a steel angle can be sistered to the structure, furthering the stability.
 - The repaired area should be monitored for further damage. If the new material shows signs of damage, a structural engineer should be consulted.
- Electrical

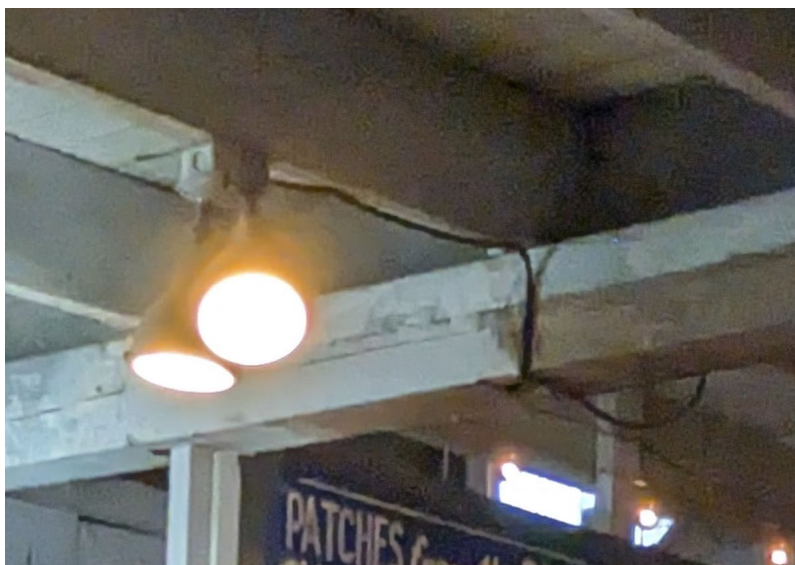
The Carriage House at Rombach Place has no heating or plumbing systems present in the building. The extant electrical system is comprised of modern surface-mounted switches, fixtures, and wires. The only issues observed from inspecting the electrical system is un-sheathed electrical wires, that do not sit within metal conduit (Figures 4-22, 4-23). The lack of metal conduit can lead to serious issues resulting from physical abrasion with the wires, potentially leading to the risk of fire.

Figure 4-22. Exposed electrical wiring, first floor southern side, 2025

- A licensed electrician should install metal conduits over the currently exposed wires to prevent damage.

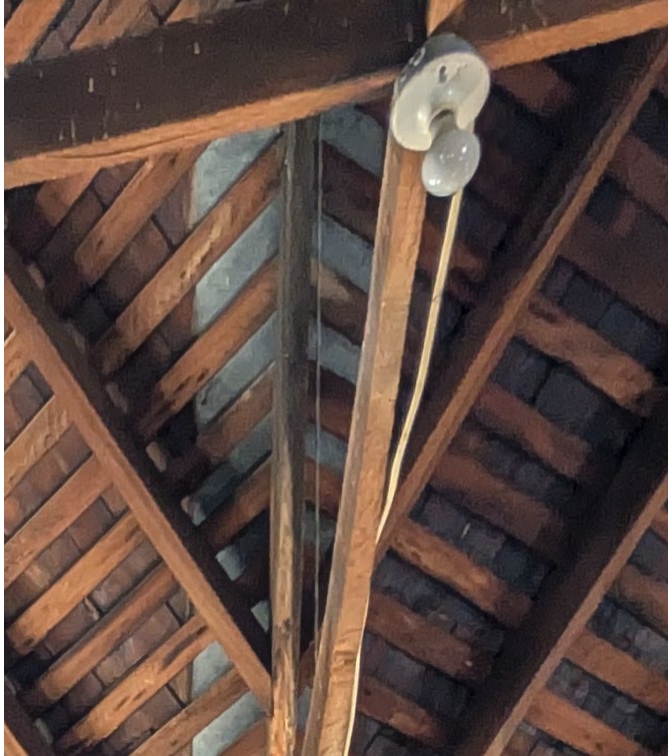
Figure 4-23. Exposed electrical wiring, second floor, 2025
