GRAY & PAPE

HERITAGE MANAGEMENT

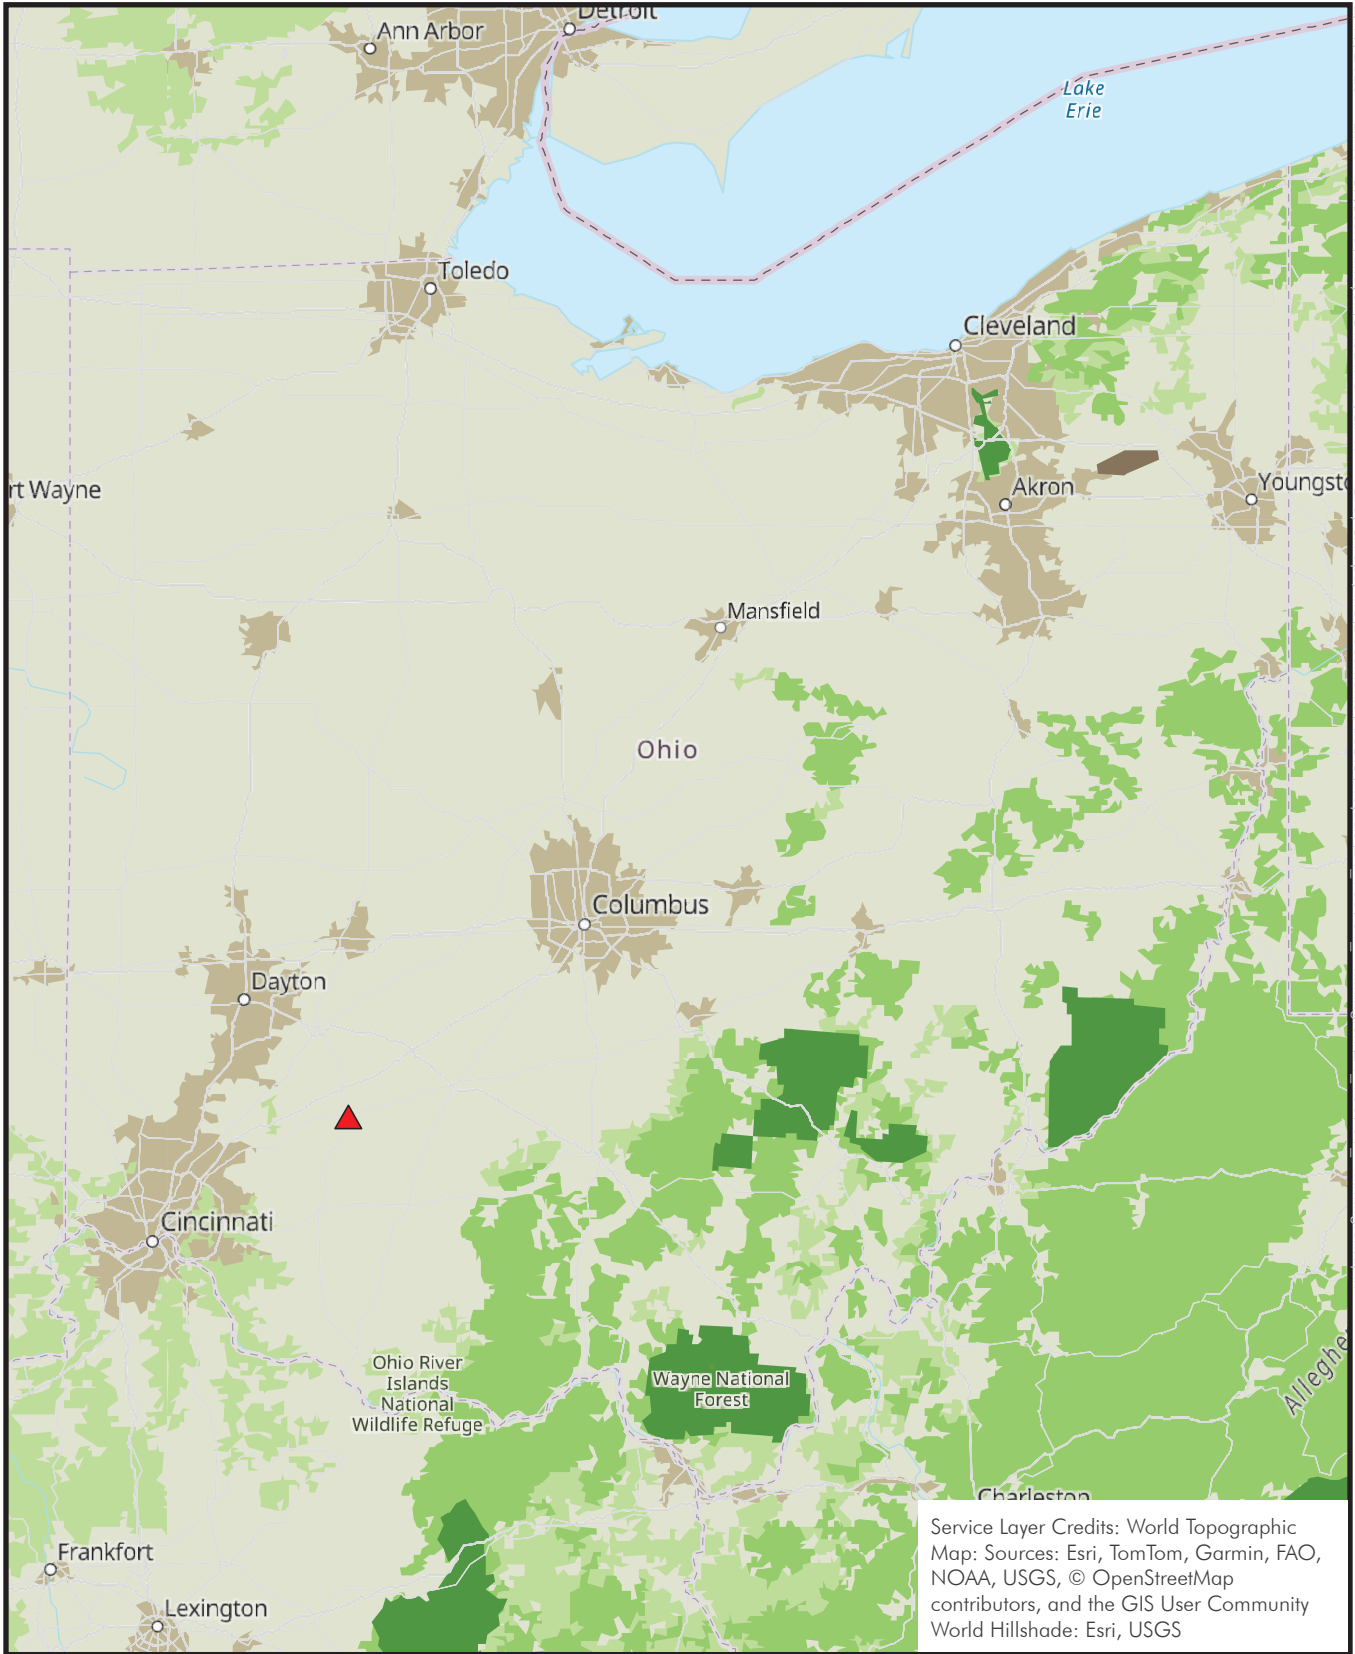
Service Layer Credits: World Topographic Map: Sources: Esri, TomTom, Garmin, FAO, NOAA, USGS, © OpenStreetMap contributors, and the GIS User Community
 World Hillshade: Esri, USGS

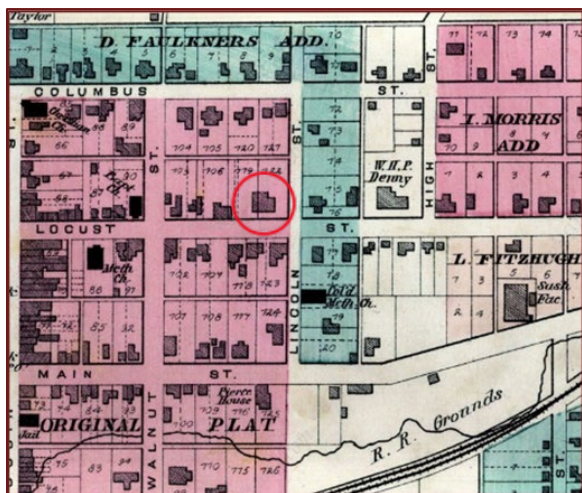
Figure 2-11. Detail from Lake, Griffing, and Stevenson, Clinton County Ohio, 1876. During Rombach Place's Second Period. Rombach Place is circled. This image shows a shallow, one-room-long ell.

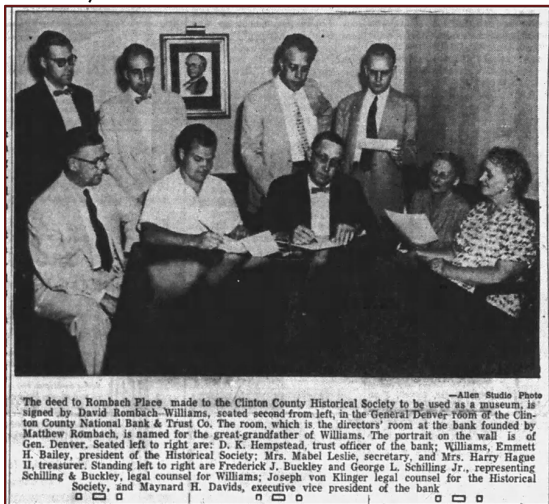
Figure 2-16. David R Williams and the Clinton County Historical Society signing the deed for Rombach Place (Wilmington News-Journal 1955).

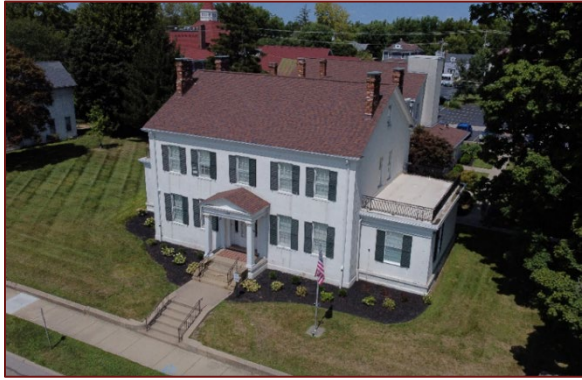
Figure 4-1. Rombach Place 2024, primary (south) facade, facing northwest, 2024.

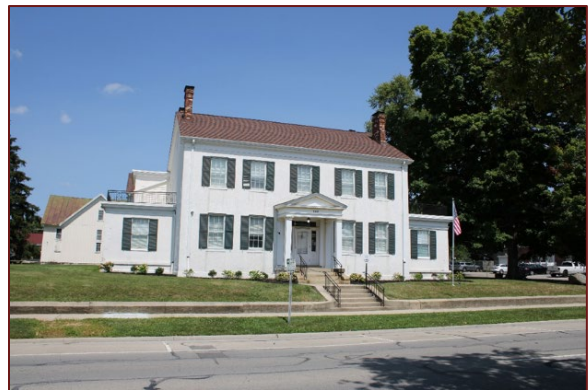
Figure 4-2. Rombach Place 2024, main (south) facade showing proximity to the street, facing northeast, 2024.

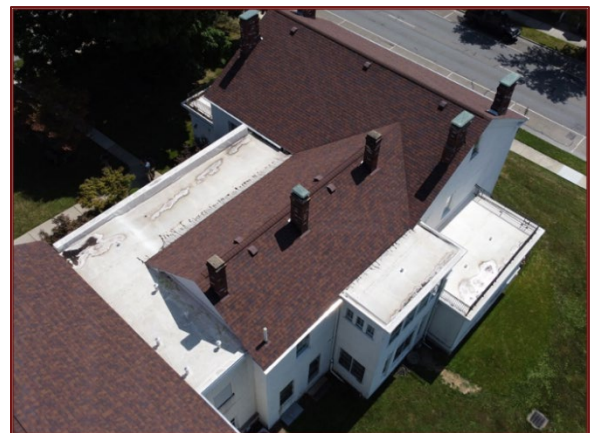
Figure 4-3. Aerial image of Rombach Place roof, facing southeast, 2024.

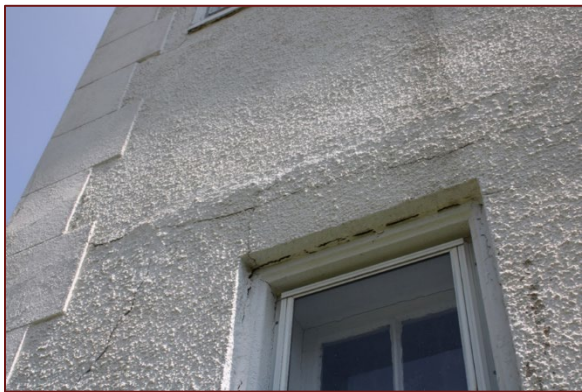
Figure 4-4. Detail of stucco cracking in window frame and lintel on the western facade, facing east, 2024.

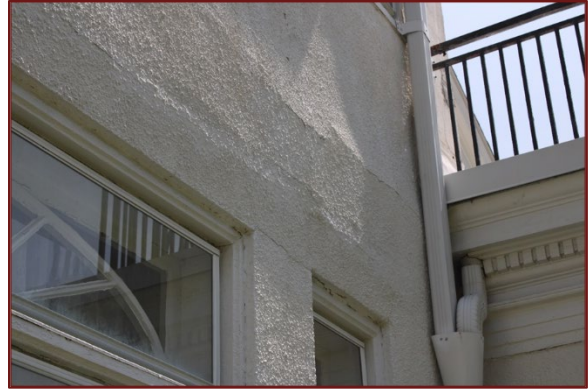
Figure 4-5. Delaminating stucco on the western facade, facing southeast, 2024.

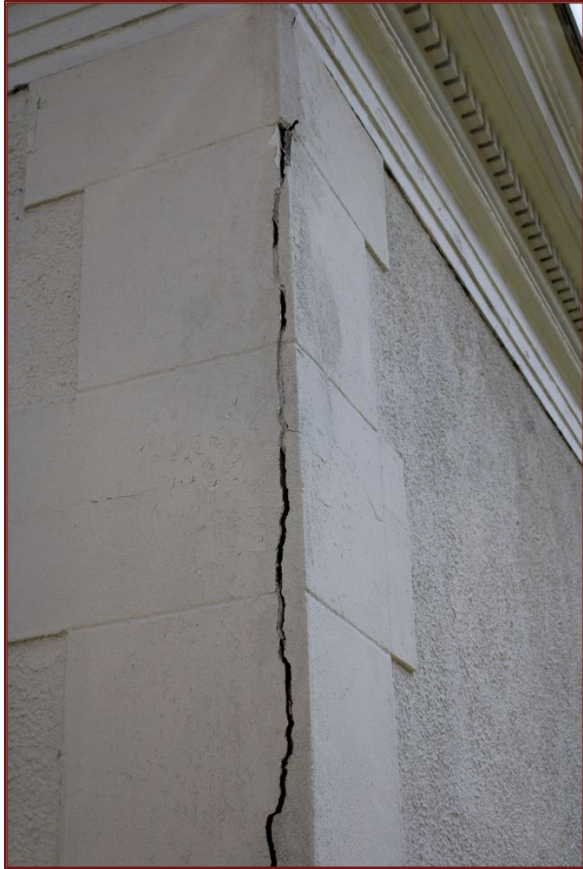
Figure 4-6. Example of stucco cracking, western enclosed patio, facing northeast, 2024.

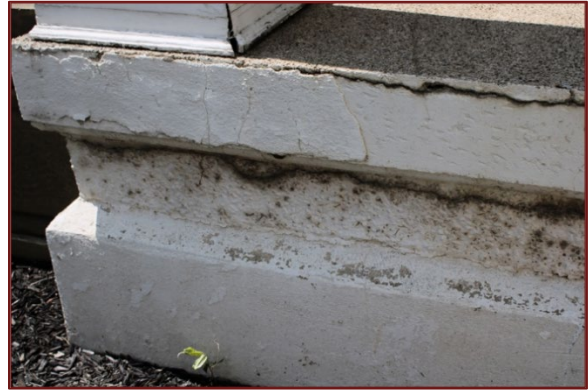
Figure 4-7. Example of concrete cracking, front entry porch, facing west, 2024.

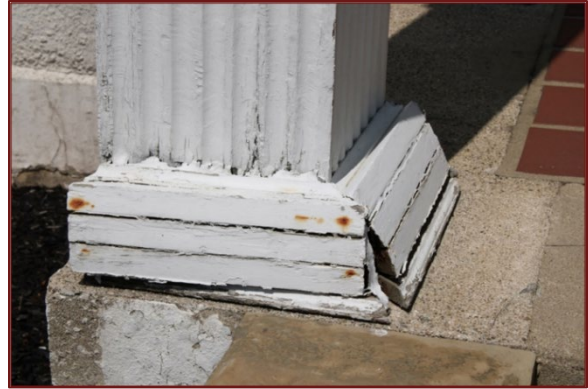
Figure 4-8. Example of wood rot, southwestern entry porch column, facing north, 2024.

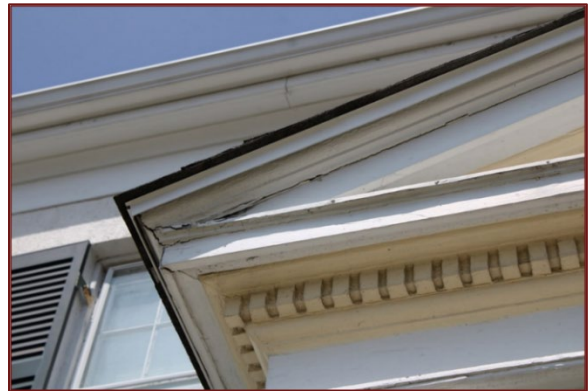
Figure 4-9. Example of wood rot, front entry portico, facing north, 2024.

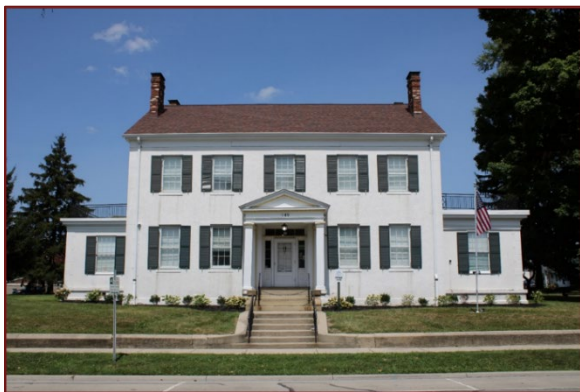
Figure 4-10. Main Façade from East Locust Street, facing north, 2024.

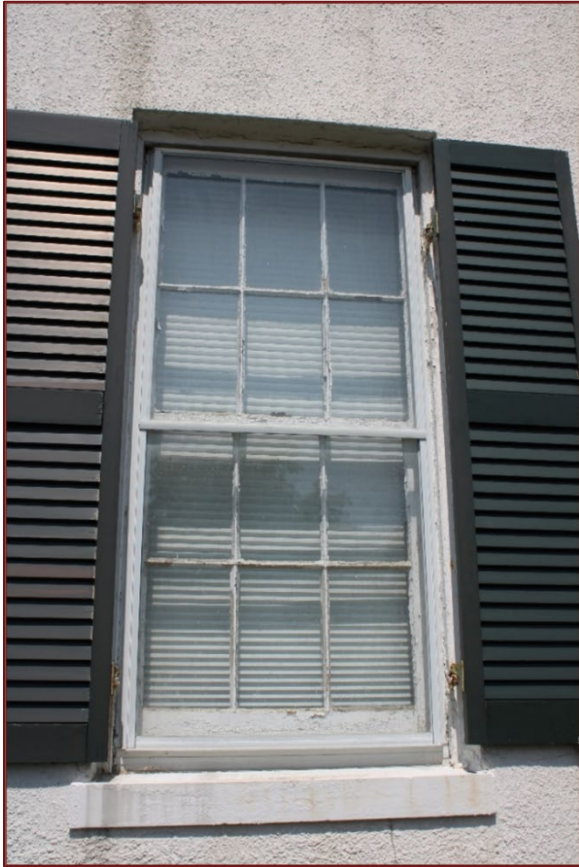
Figure 4-13. Historic, six-over-six window on the western façade, first floor, showing damage typical to most windows in the building, damaged glazing putty, and paint damage, facing east, 2024.

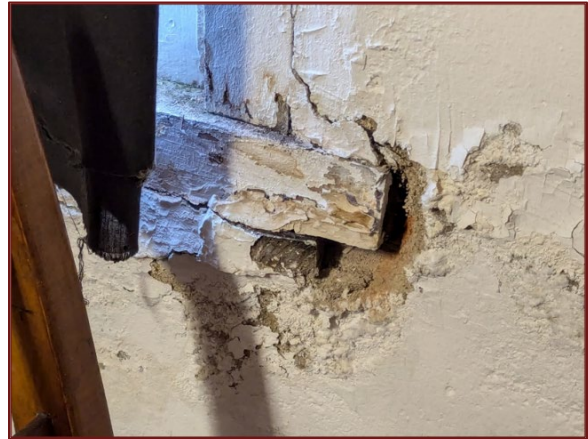
Figure 4-14. Third-floor window showing extreme moisture damage, 2024.

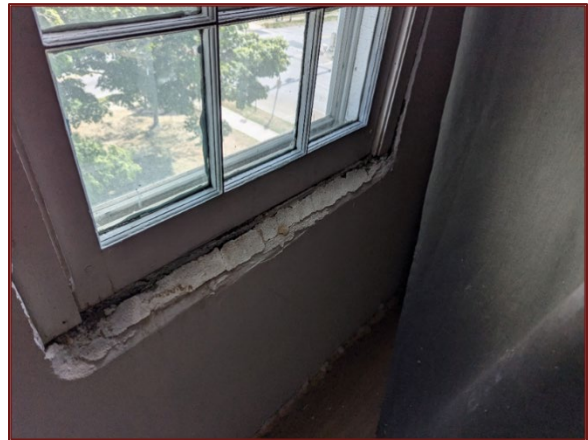
Figure 4-15. Third-floor window showing damage, 2024.

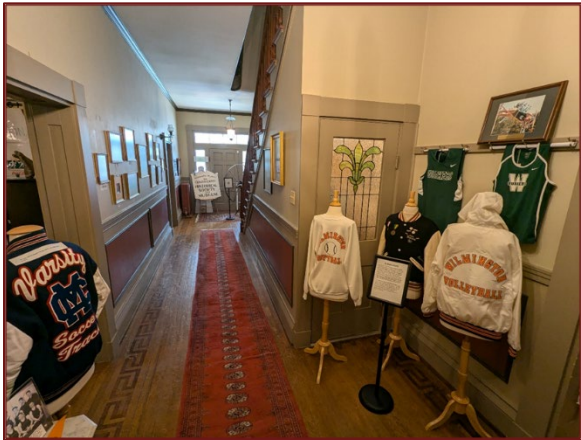
Figure 4-19. Room 1-2, including under-staircase-stained glass, 2024.

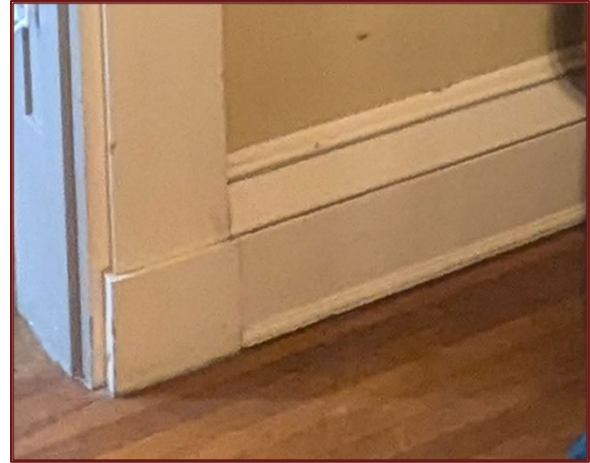
Figure 4-22. Greek Revival baseboard in Room 1-3, identical to that in Room 4, 2025.

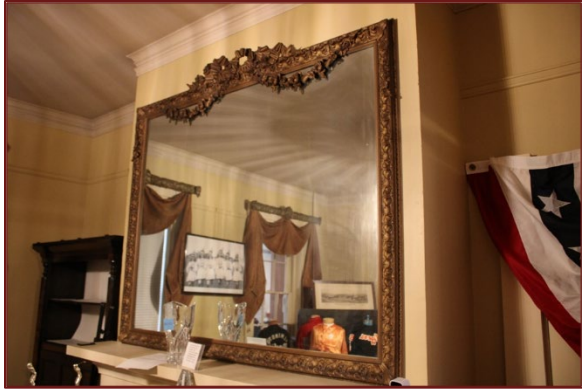
Figure 4-23. Over-mantle mirrors identical in Rooms 1-3 and 1-6, 2025.

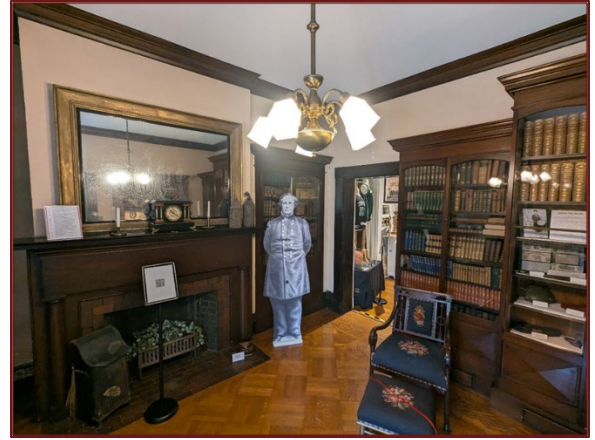
Figure 4-28. Room 1-1 2024.

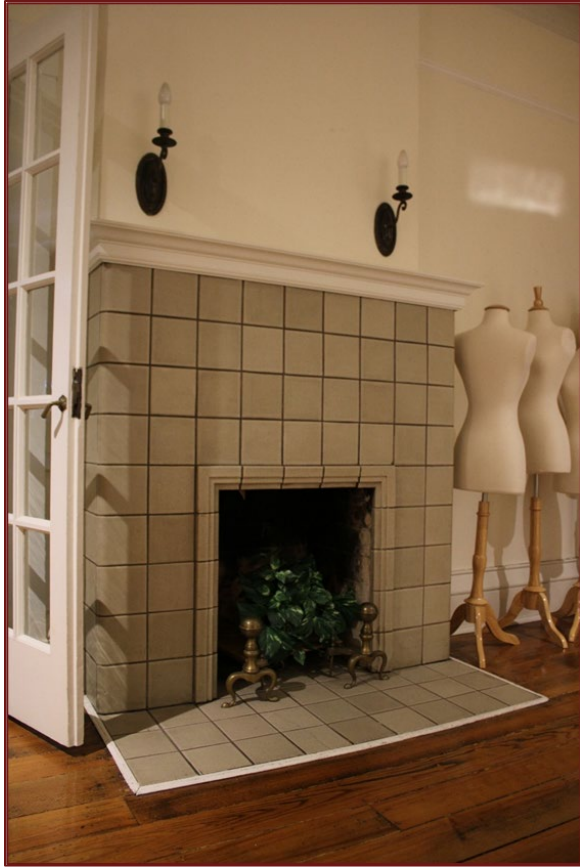
Figure 4-29. Fireplace in Room 1-7, 2025.

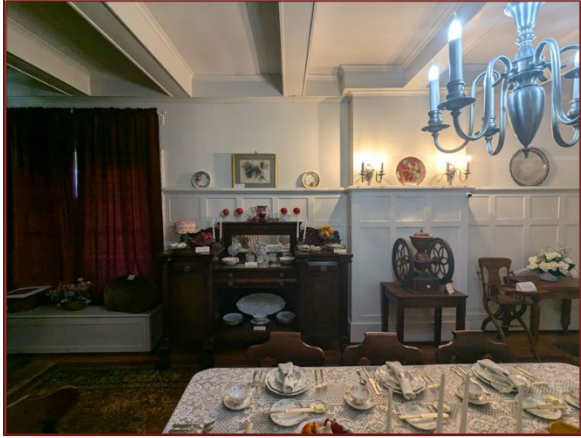
Figure 4-35. Dining Room 1-9, 2024.

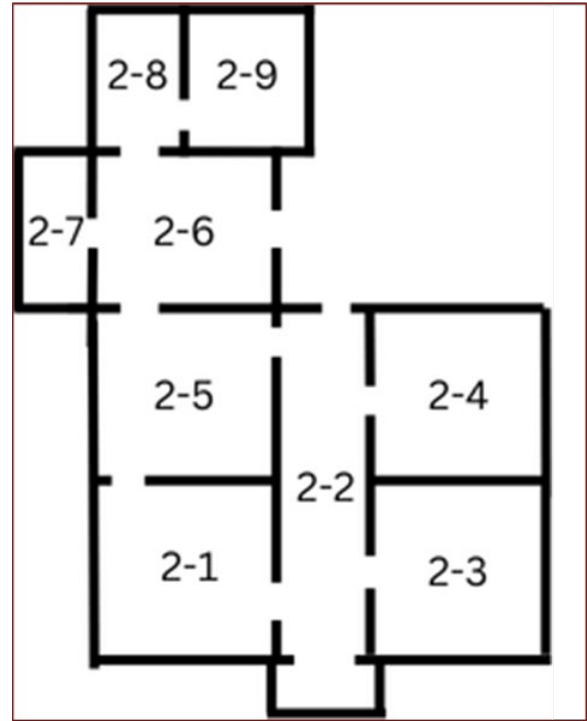
Room Key: Second Level

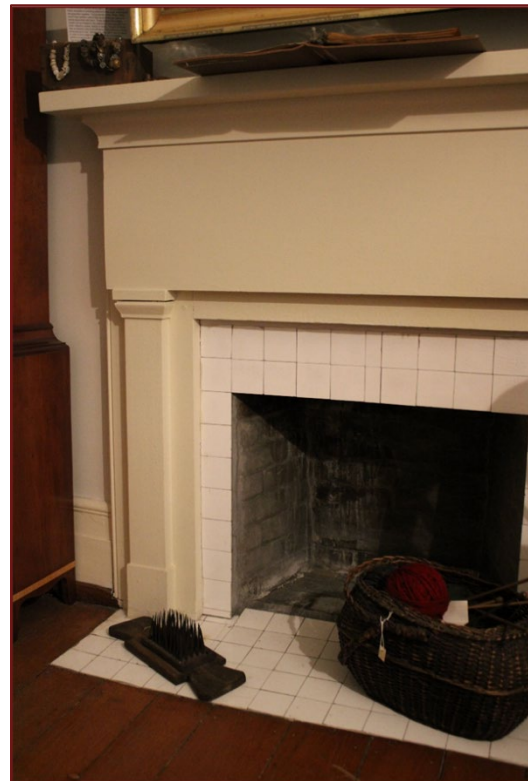
Figure 4-40. Fireplace in Room 2-3, and identical to that in Room 2-4, 2025.

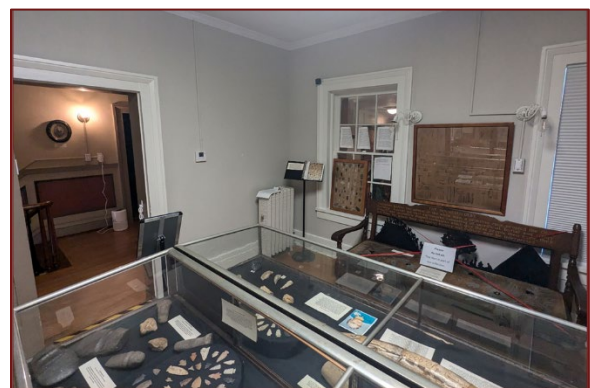
Figure 4-41. Overview of Room 2-4, with the now interior original window visible, 2025.

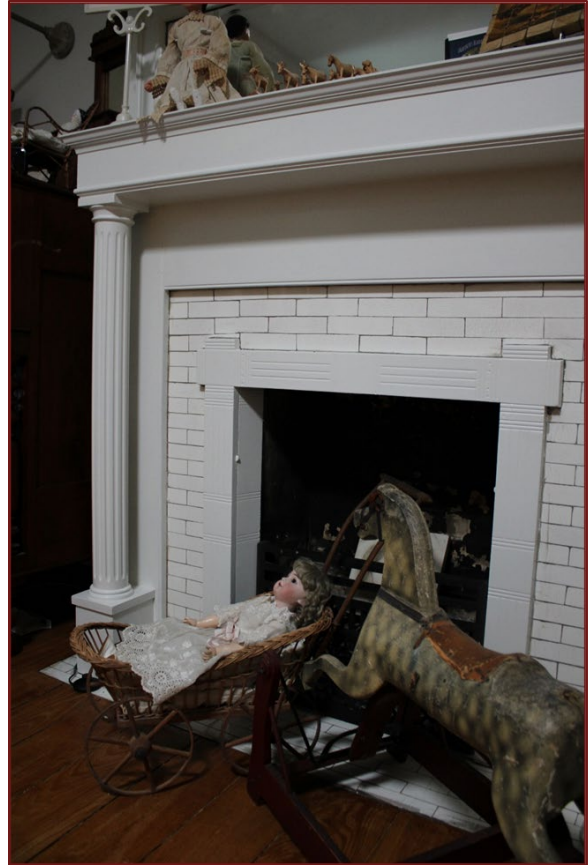
Figure 4-42. Colonial Revival fireplace and mantel in Room 2-1, 2025.

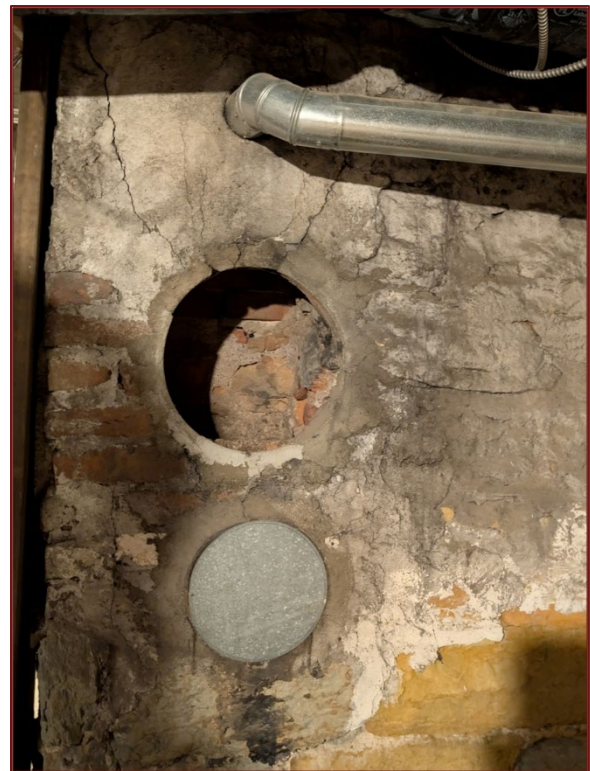
Figure 4-58. Open hole in the basement, requiring attention, 2025.

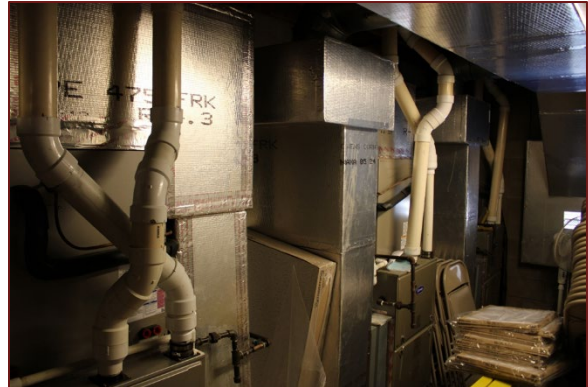
Figure 4-60. Current HVAC units, located in the 2001 built addition, 2025.

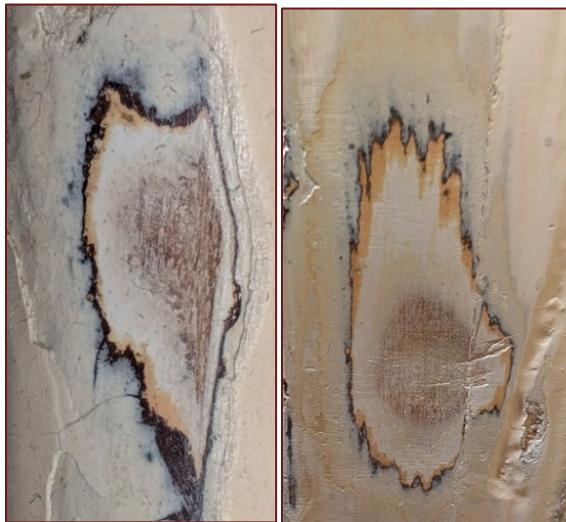
Figure 4-61. Paint Layer Analysis from Baseboard (left) and Doorframe (right), 2025.

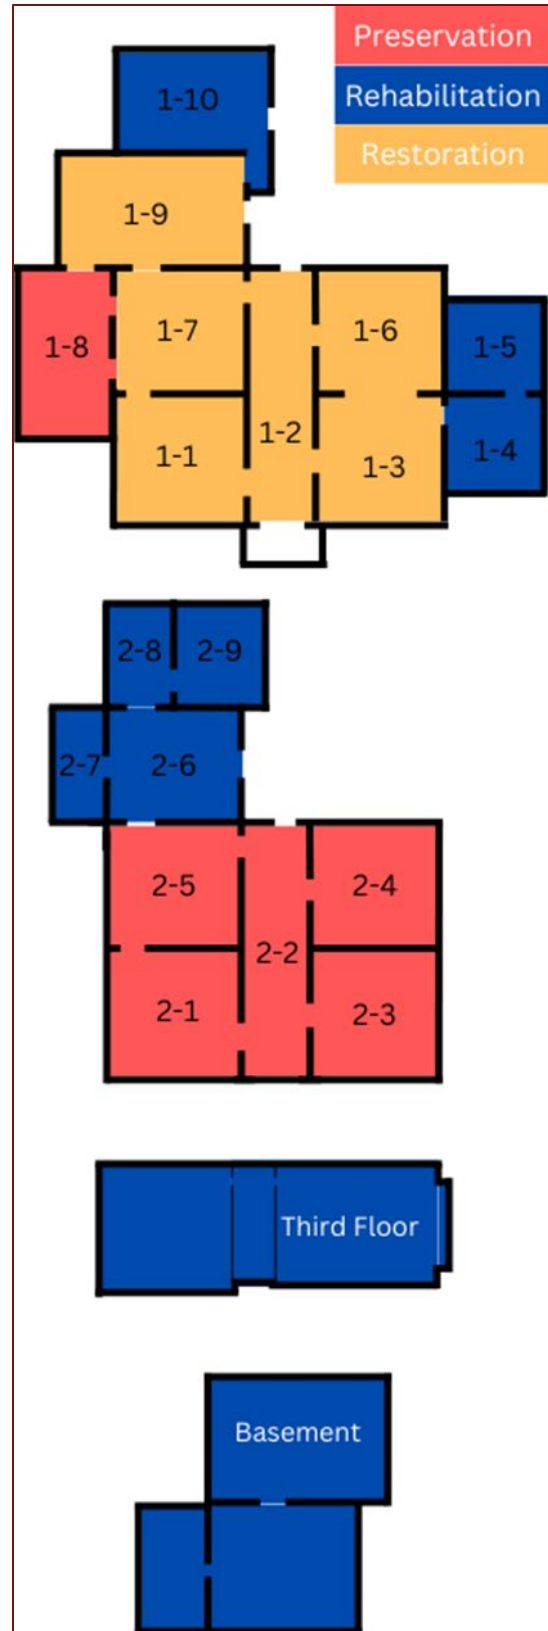
Figure 6-1. Treatment Zones Diagram and Key.

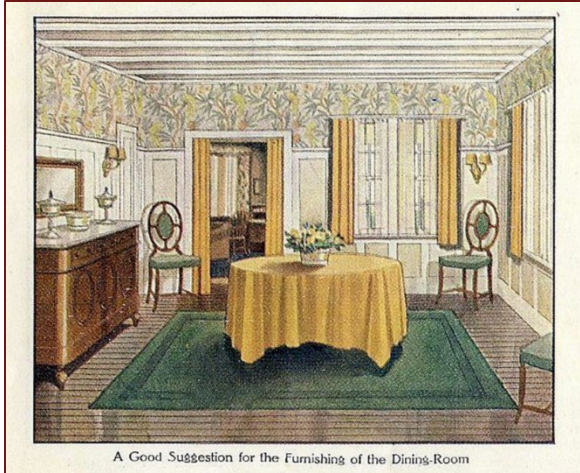
Figure 6-2. The room shown is similar to the 1919 Dining Room at Rombach Place, with correct furnishings and decorative elements. Ladies Home Journal, April 1912.

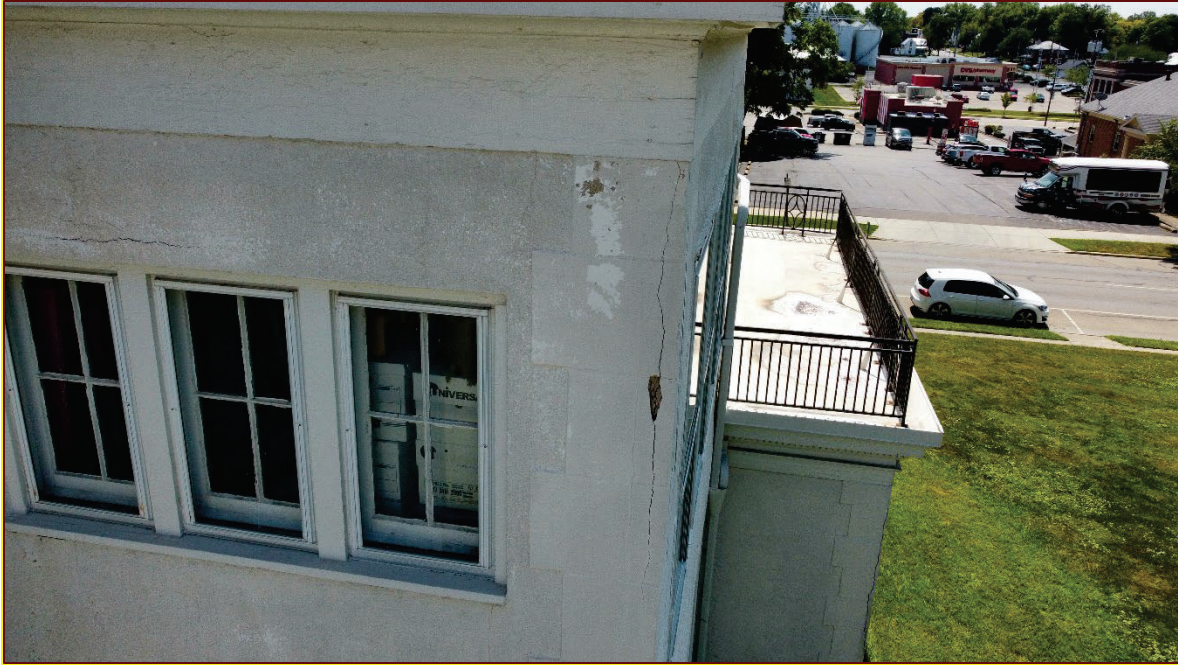
Figure A-1. Example of Stucco Cracking and Delamination, northwest corner of main section of building, facing south, 2024.

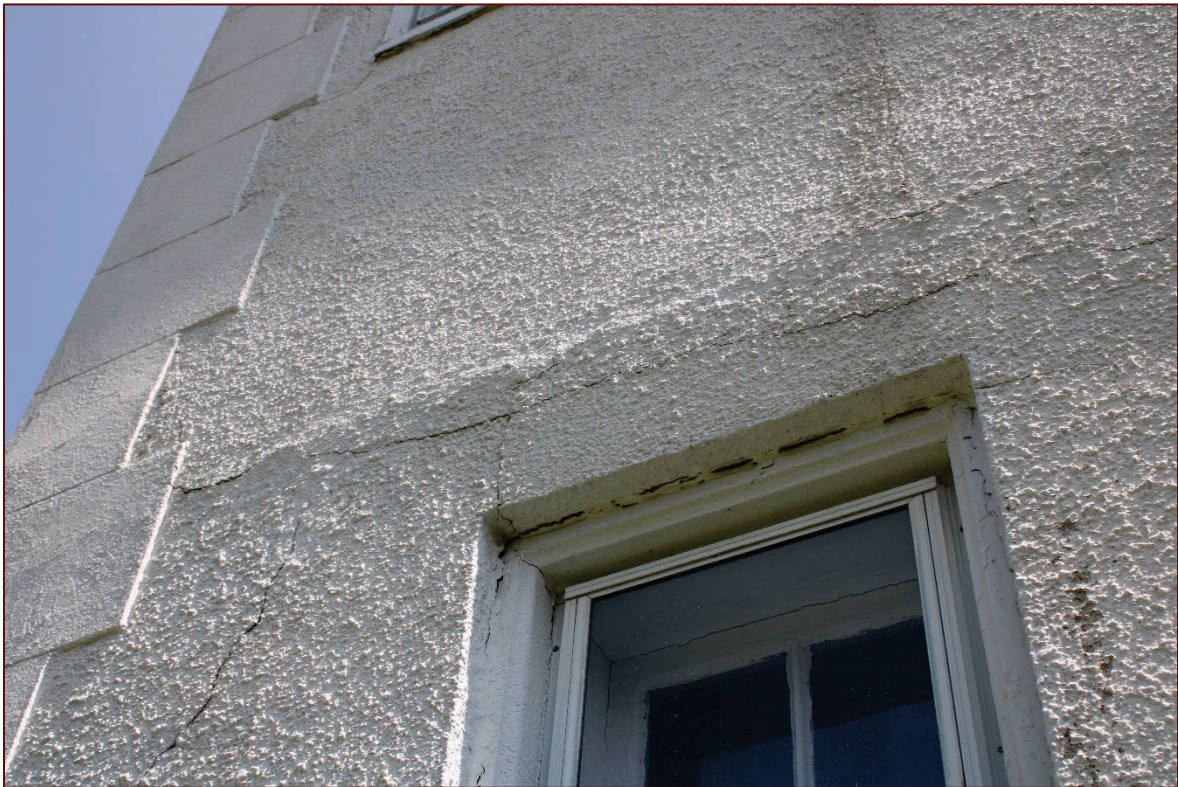
Figure A-2. Example of stucco delamination, west facade, facing east, 2024.

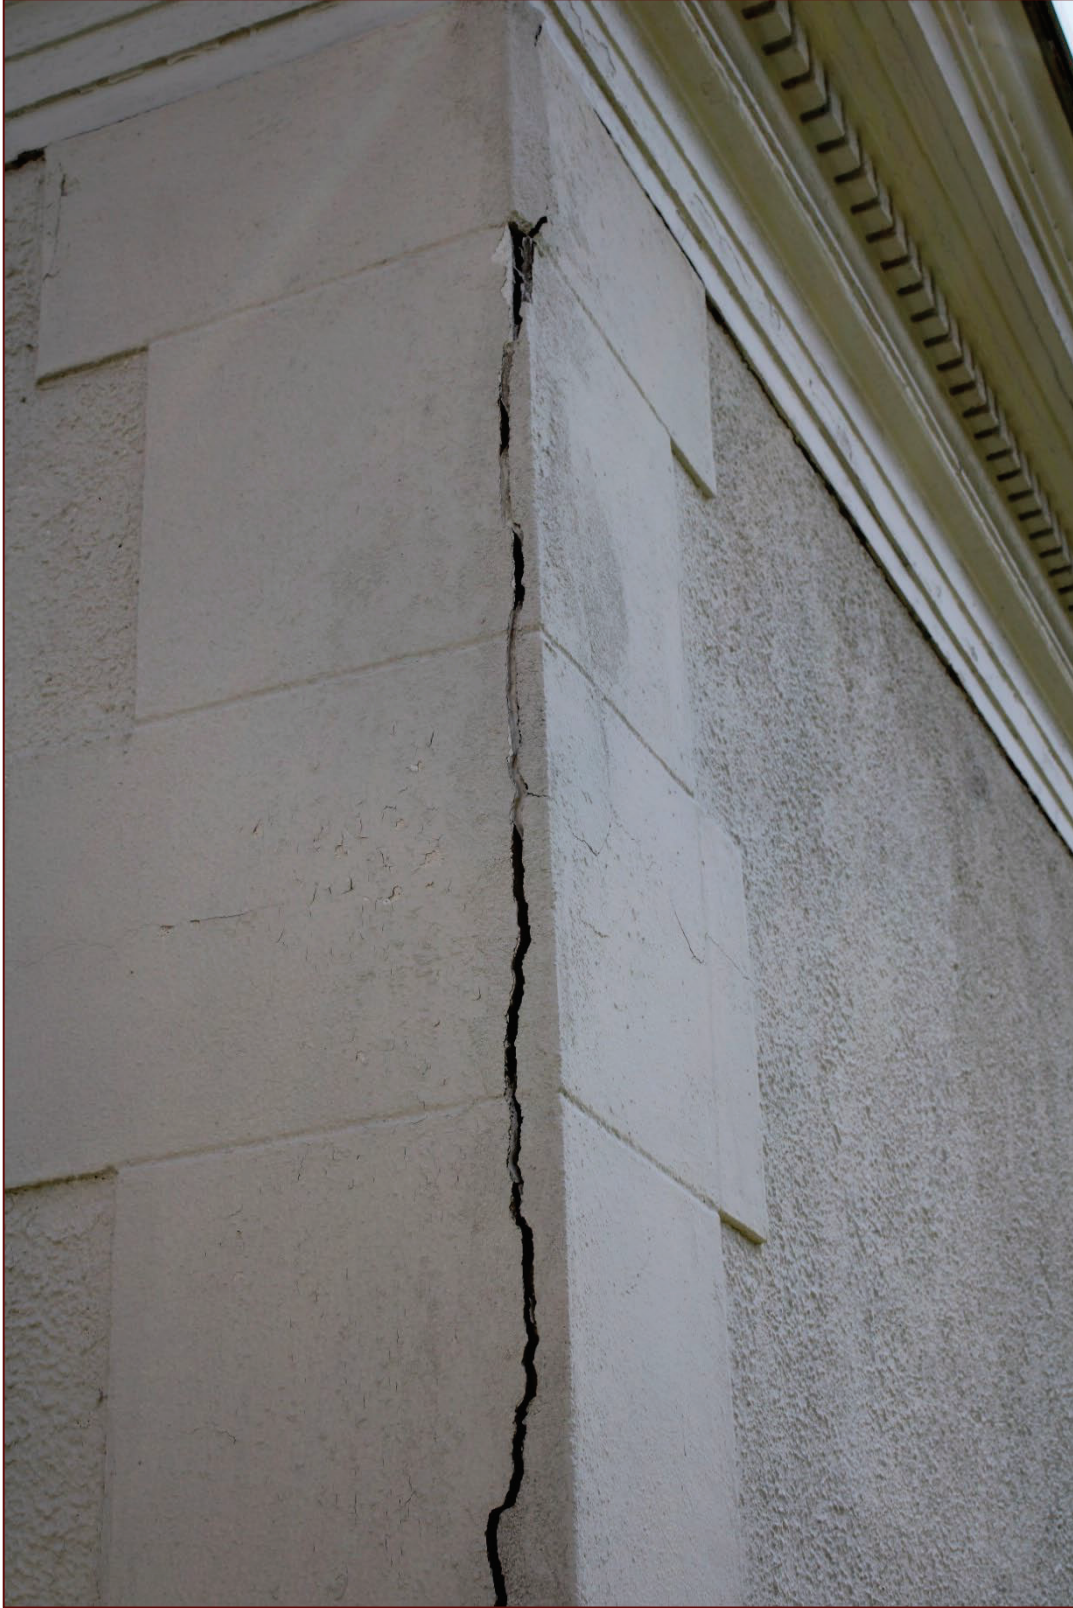
Figure A-3. Example of stucco cracking, western enclosed patio, facing northeast, 2024.

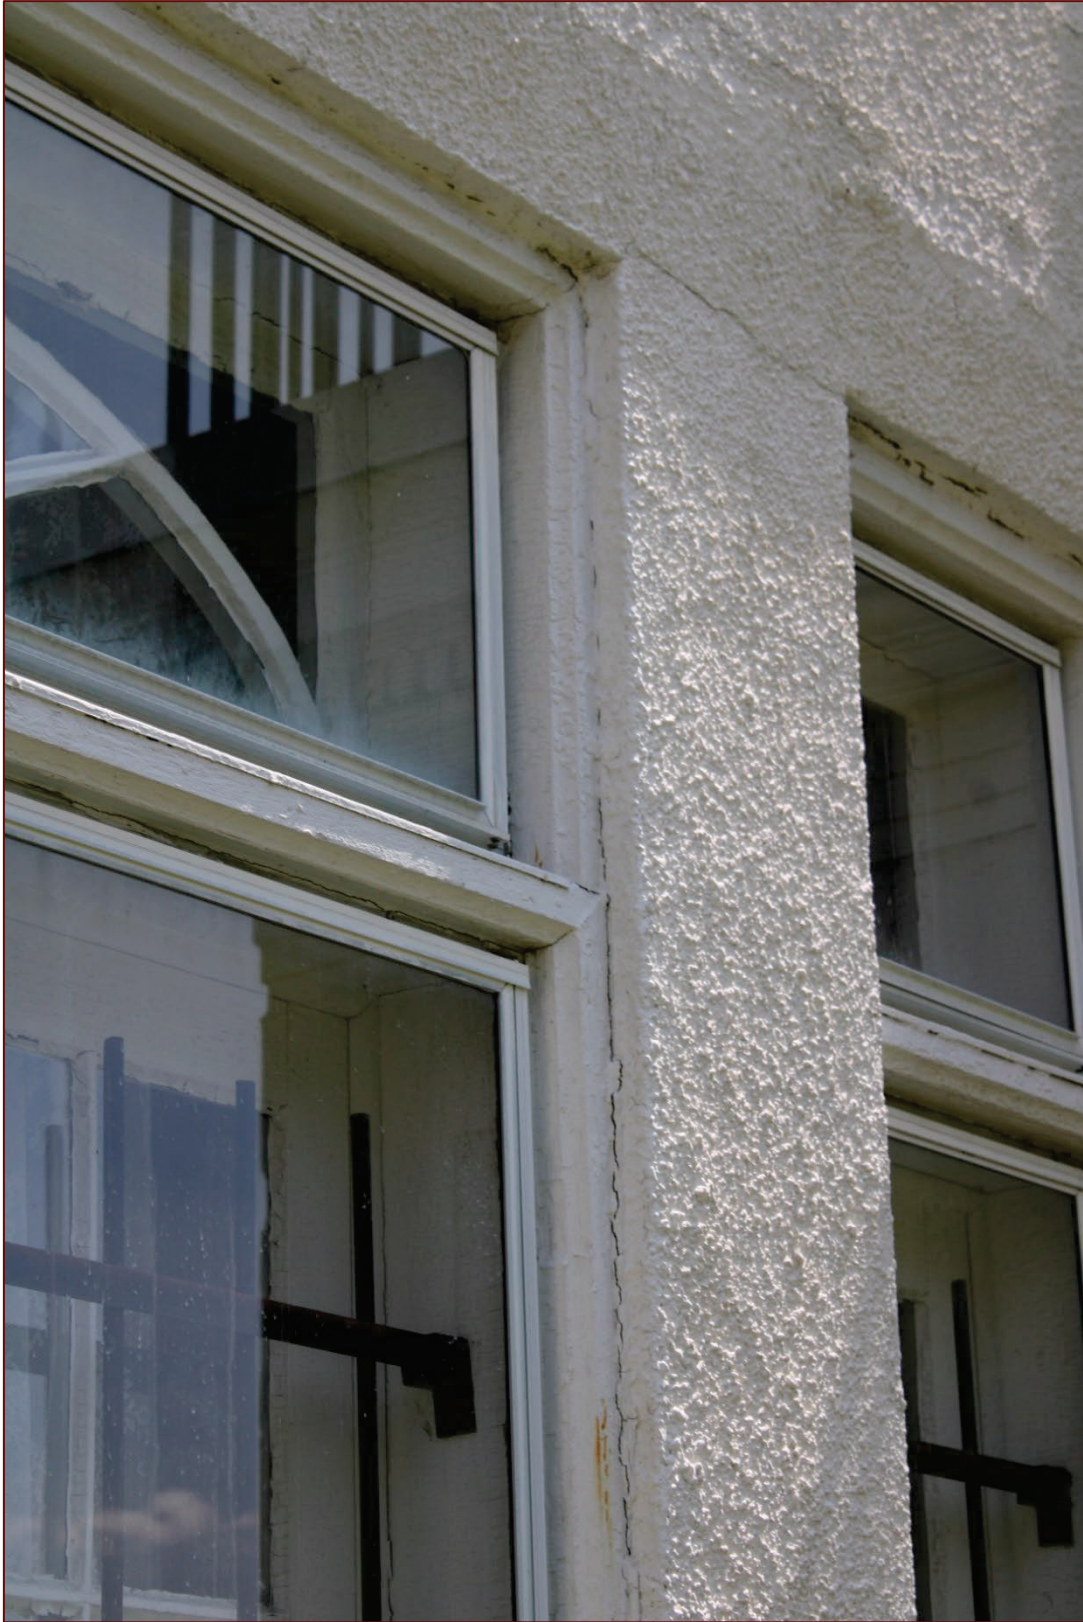
Figure A-4. Example of stucco cracking around window frame, western facade, facing southeast, 2024.

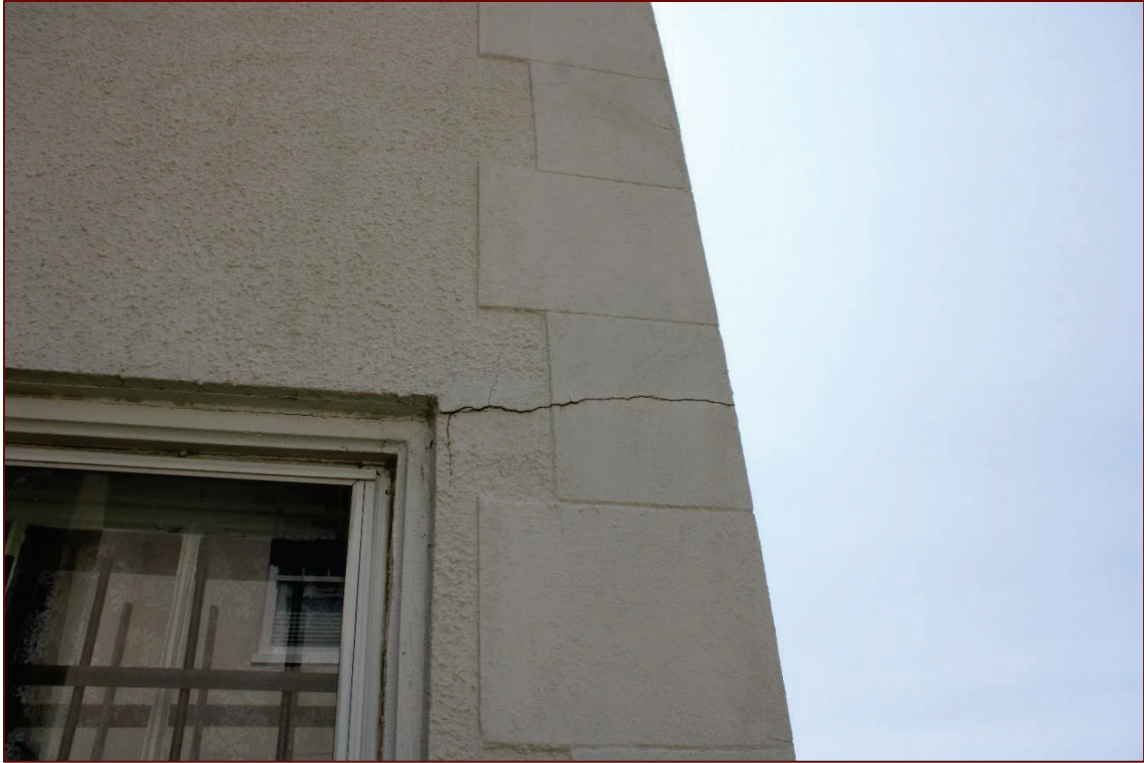
Figure A-5. Example of stucco cracking, western fern facade facing west, 2024.

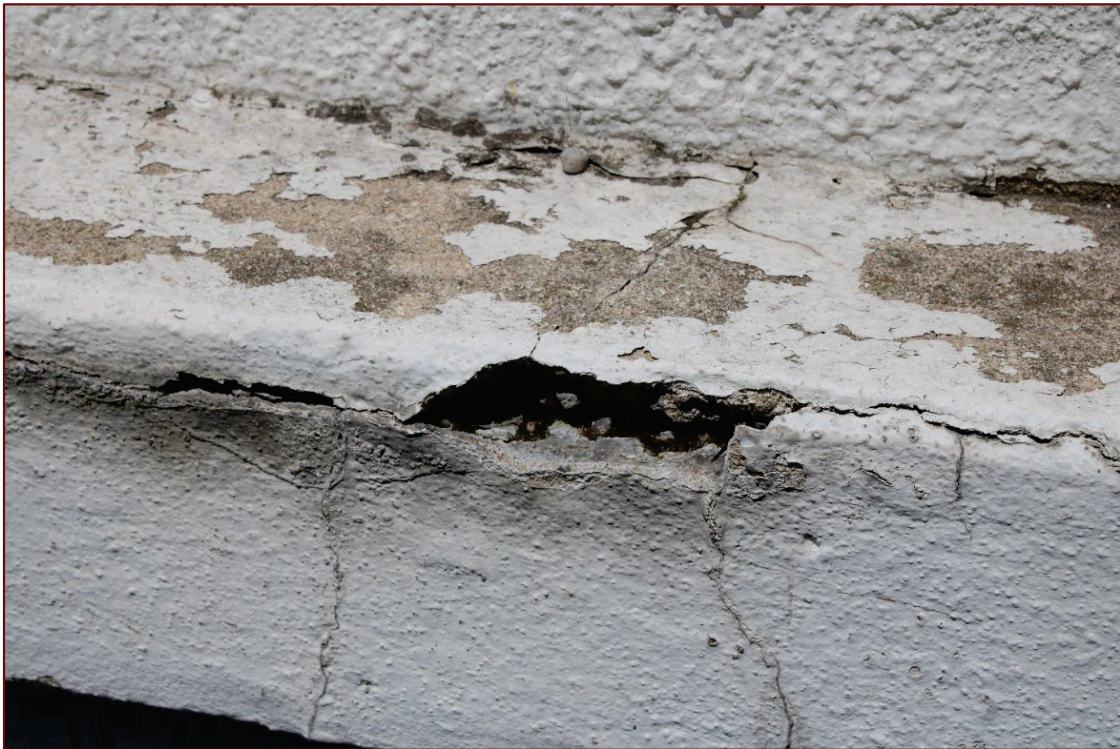
Figure A-6. Example of stucco cracking, western porch, facing east, 2024.

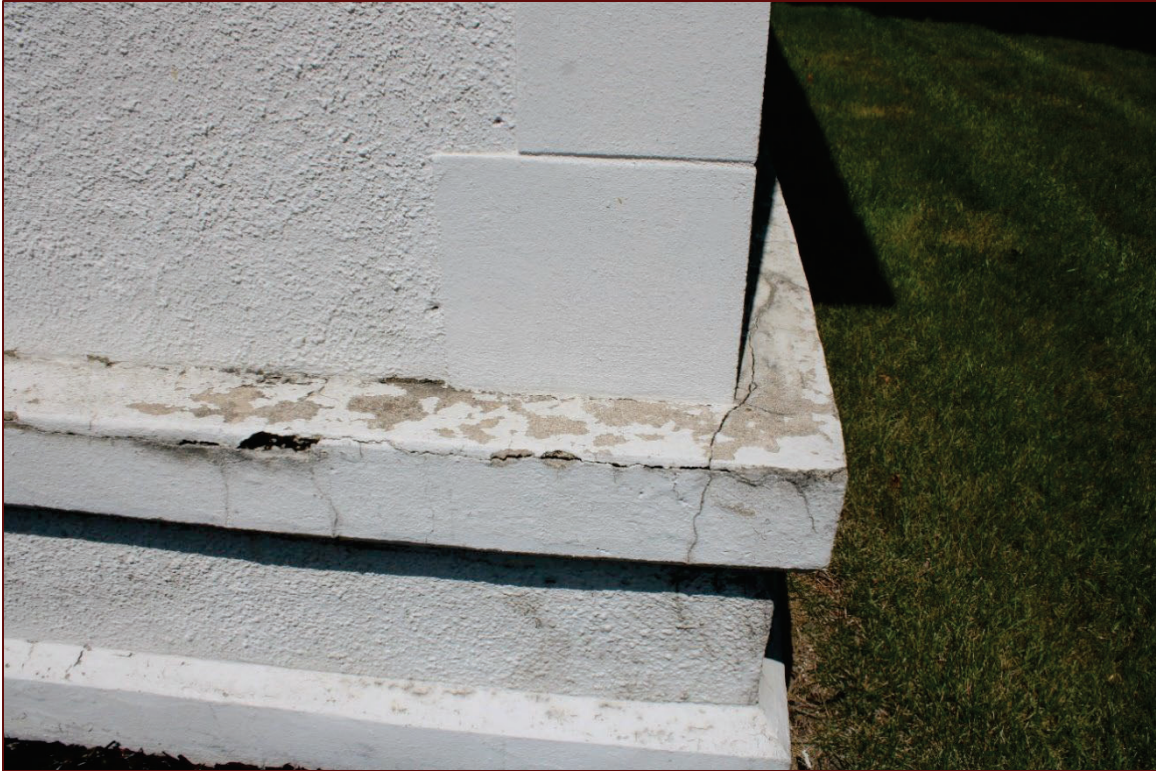
Figure A-7. Example of stucco and concrete cracking, western enclosed porch, facing east, 2024.

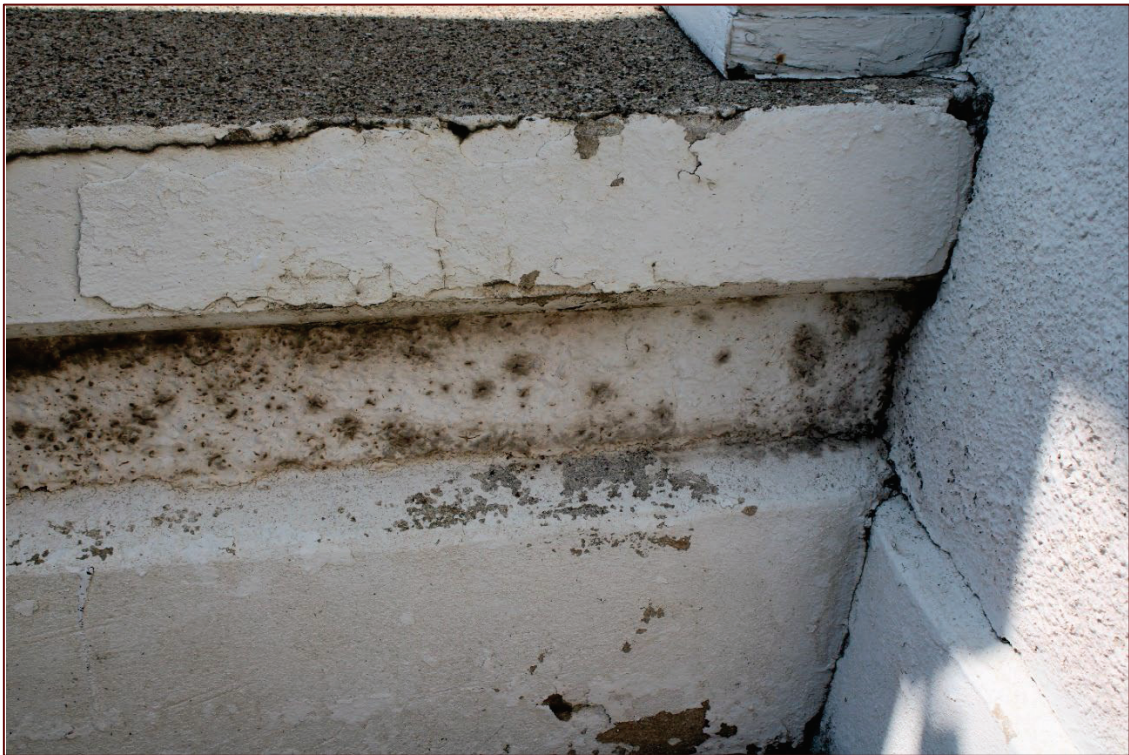
Figure A-9. Example of concrete cracking, front entry porch, facing west, 2024.

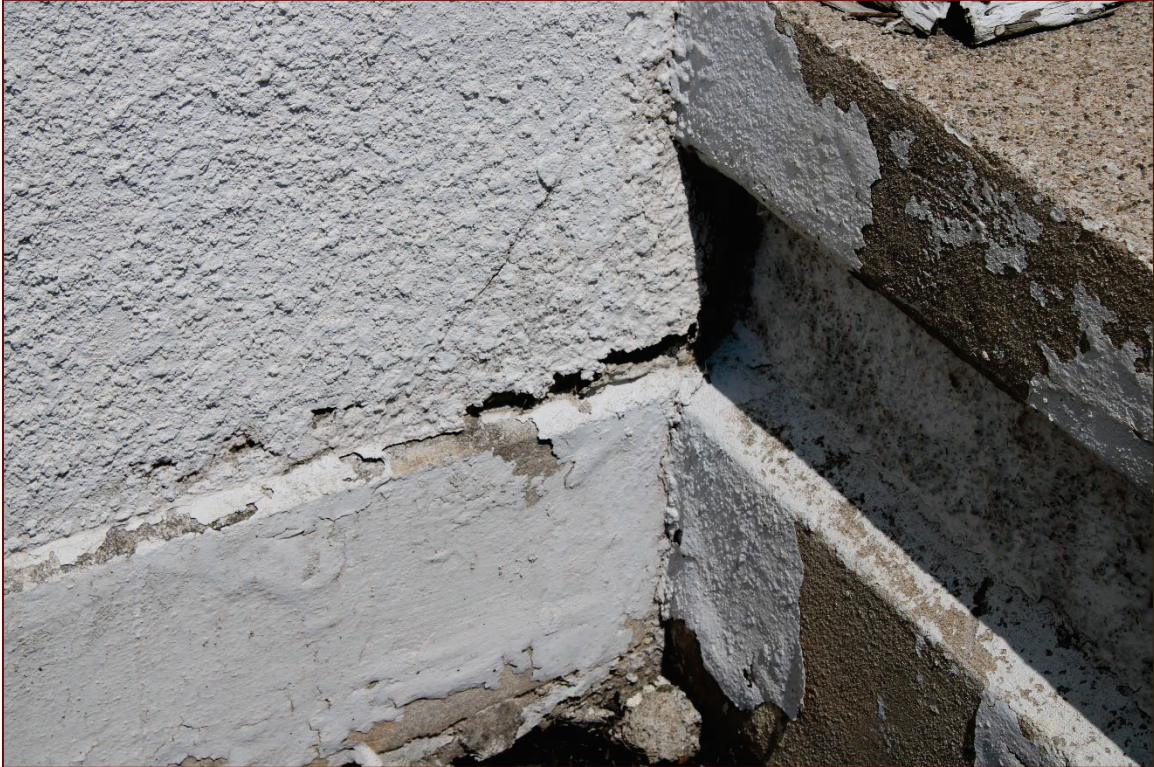
Figure A-10. Example of concrete and stucco cracking, front entry porch, facing northeast, 2024.

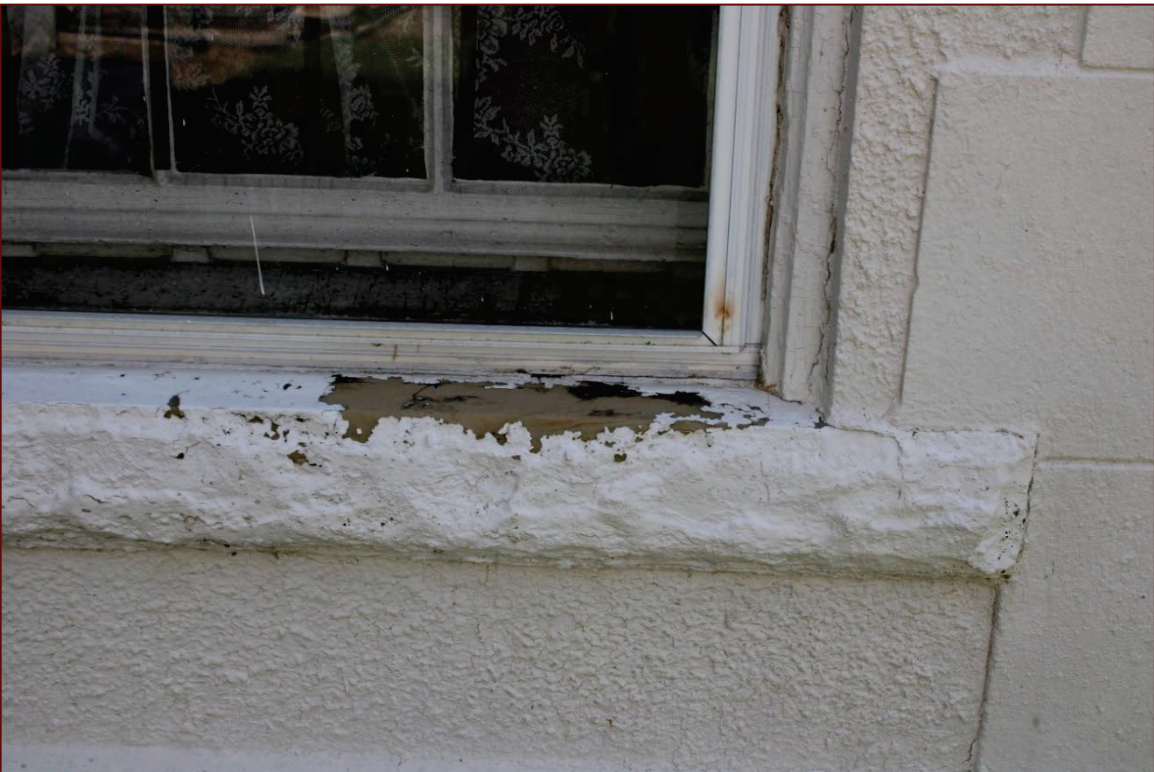
Figure A-11. Example of paint failure on original sandstone sill, western elevation, facing east, 2024.
