GRAY & PAPE

HERITAGE MANAGEMENT

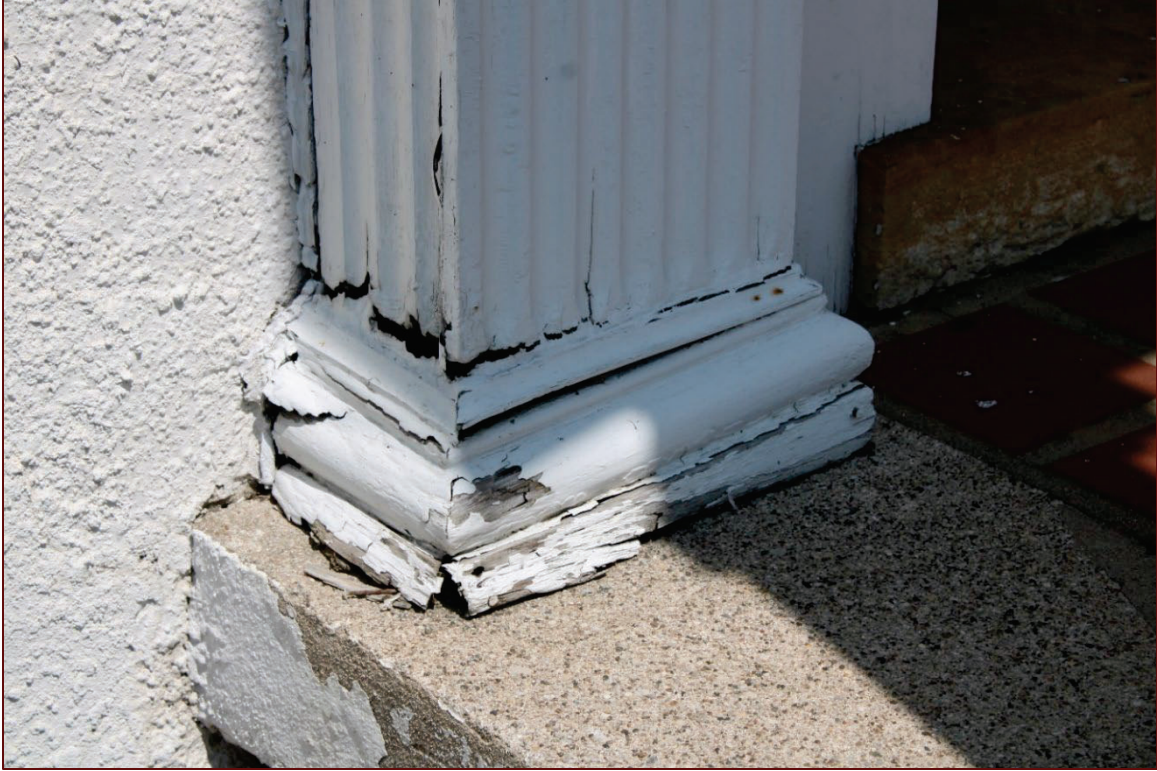
Figure A-14. Example of wood rot, northwestern pilaster, facing north, 2024.

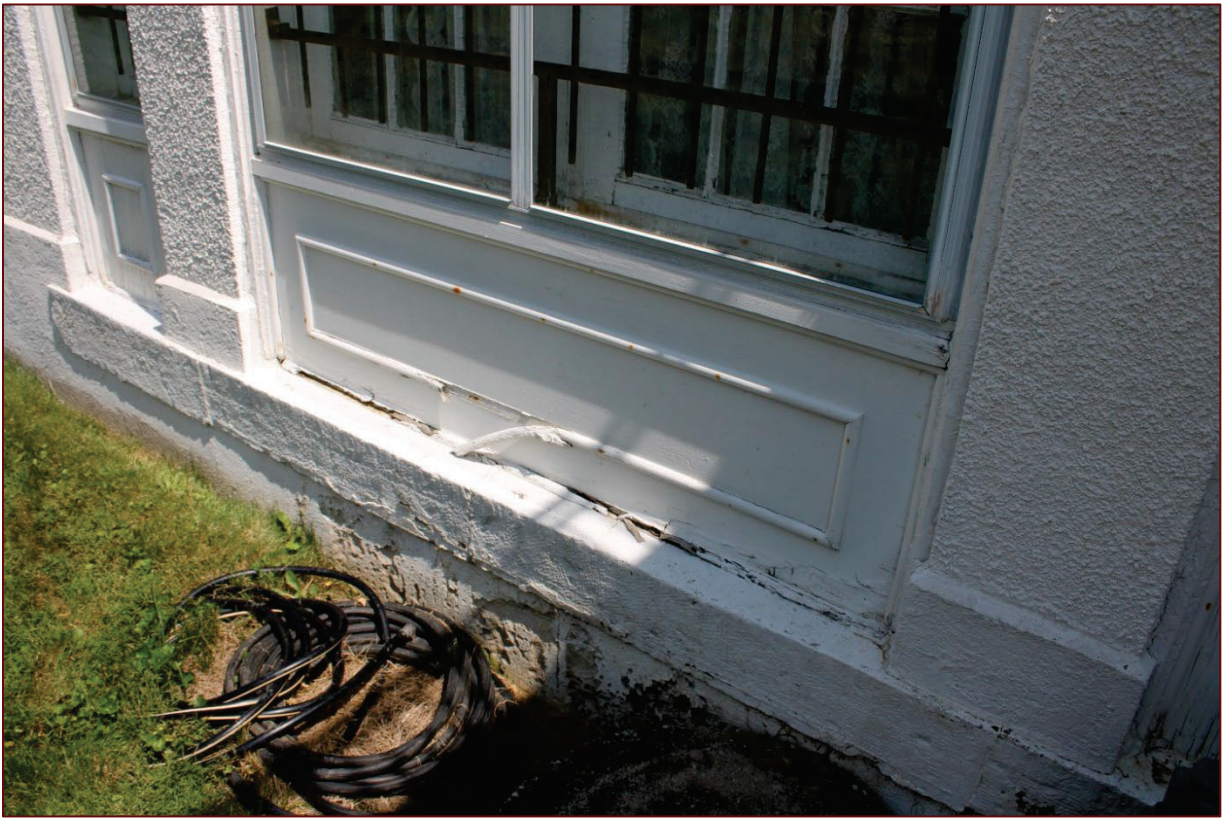
Figure A-15. Example of wood rot and paint failure, western elevation, facing northeast, 2024.

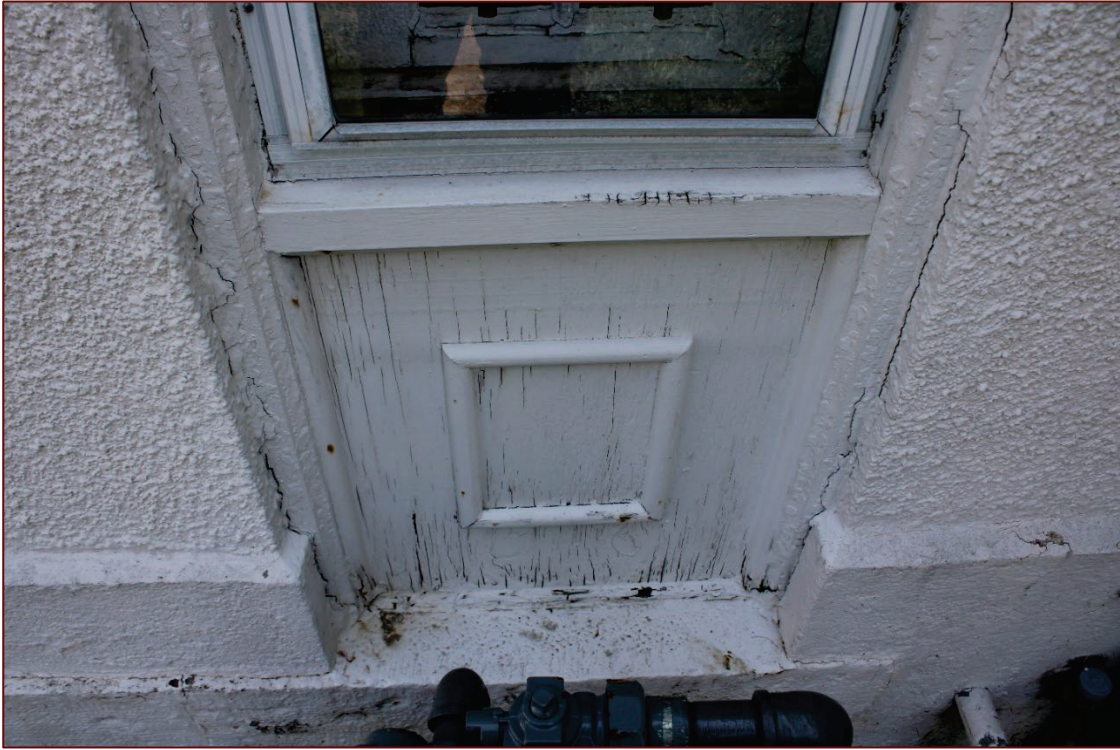
Figure A-16. Example of wood rot and paint failure, western elevation, facing east, 2024.

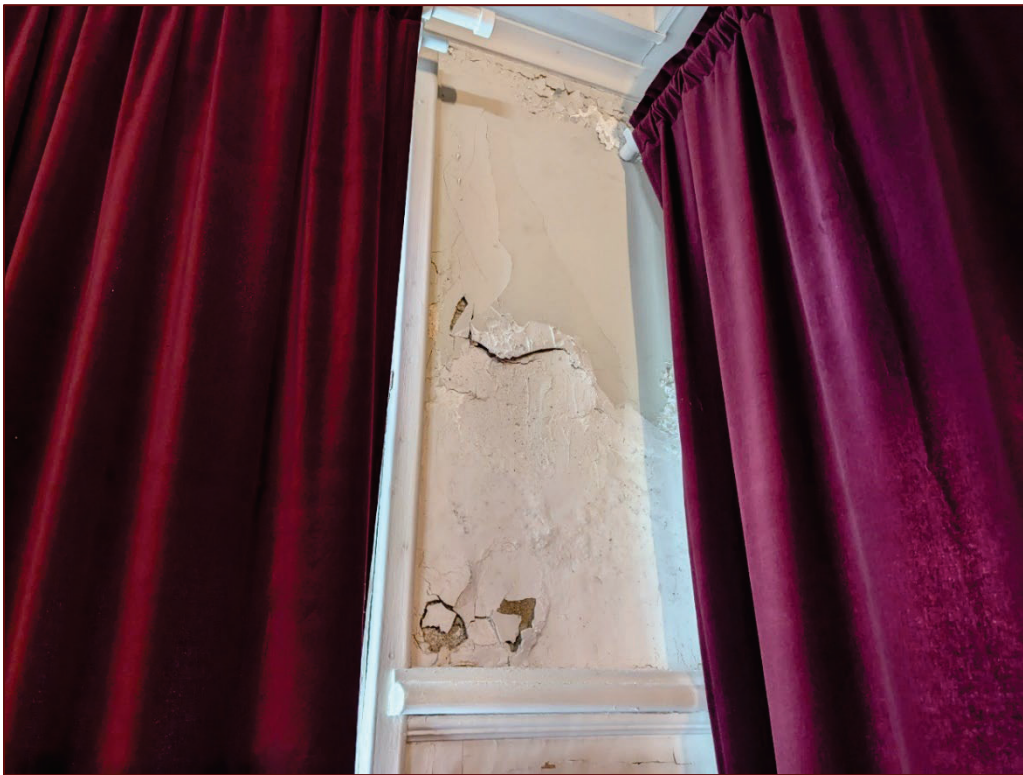
Figure A-17. Example of interior water ingress, northwest corner of dining room, 2024.

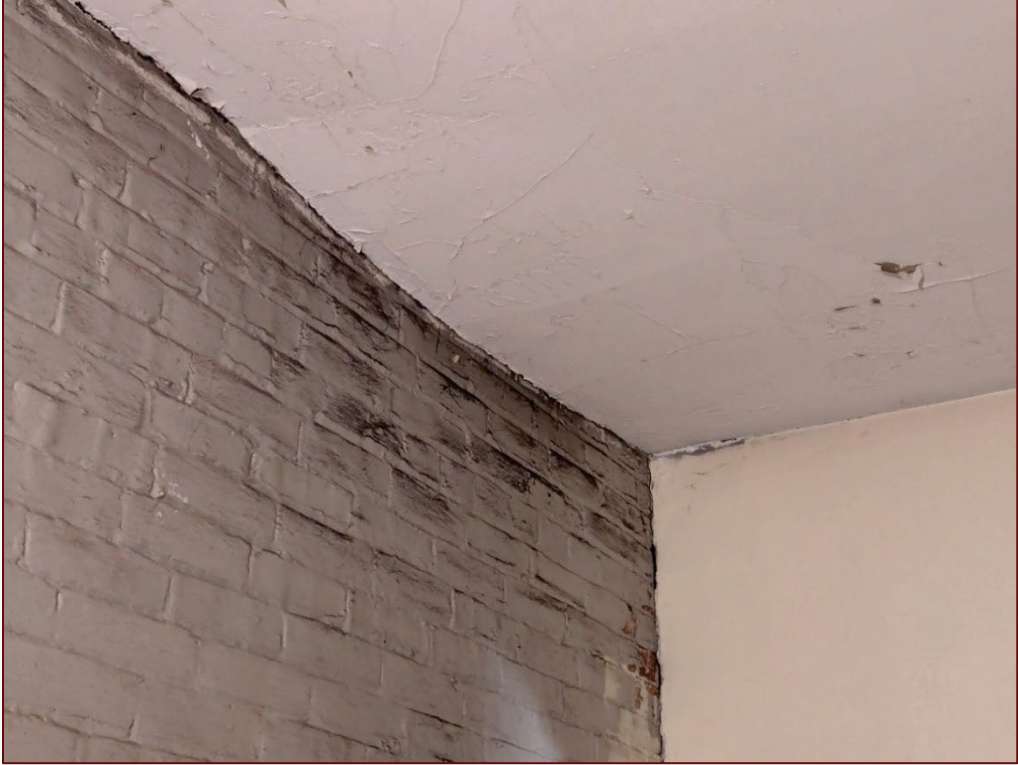
Figure A-20. Example of water damage, Room 19, 2024.

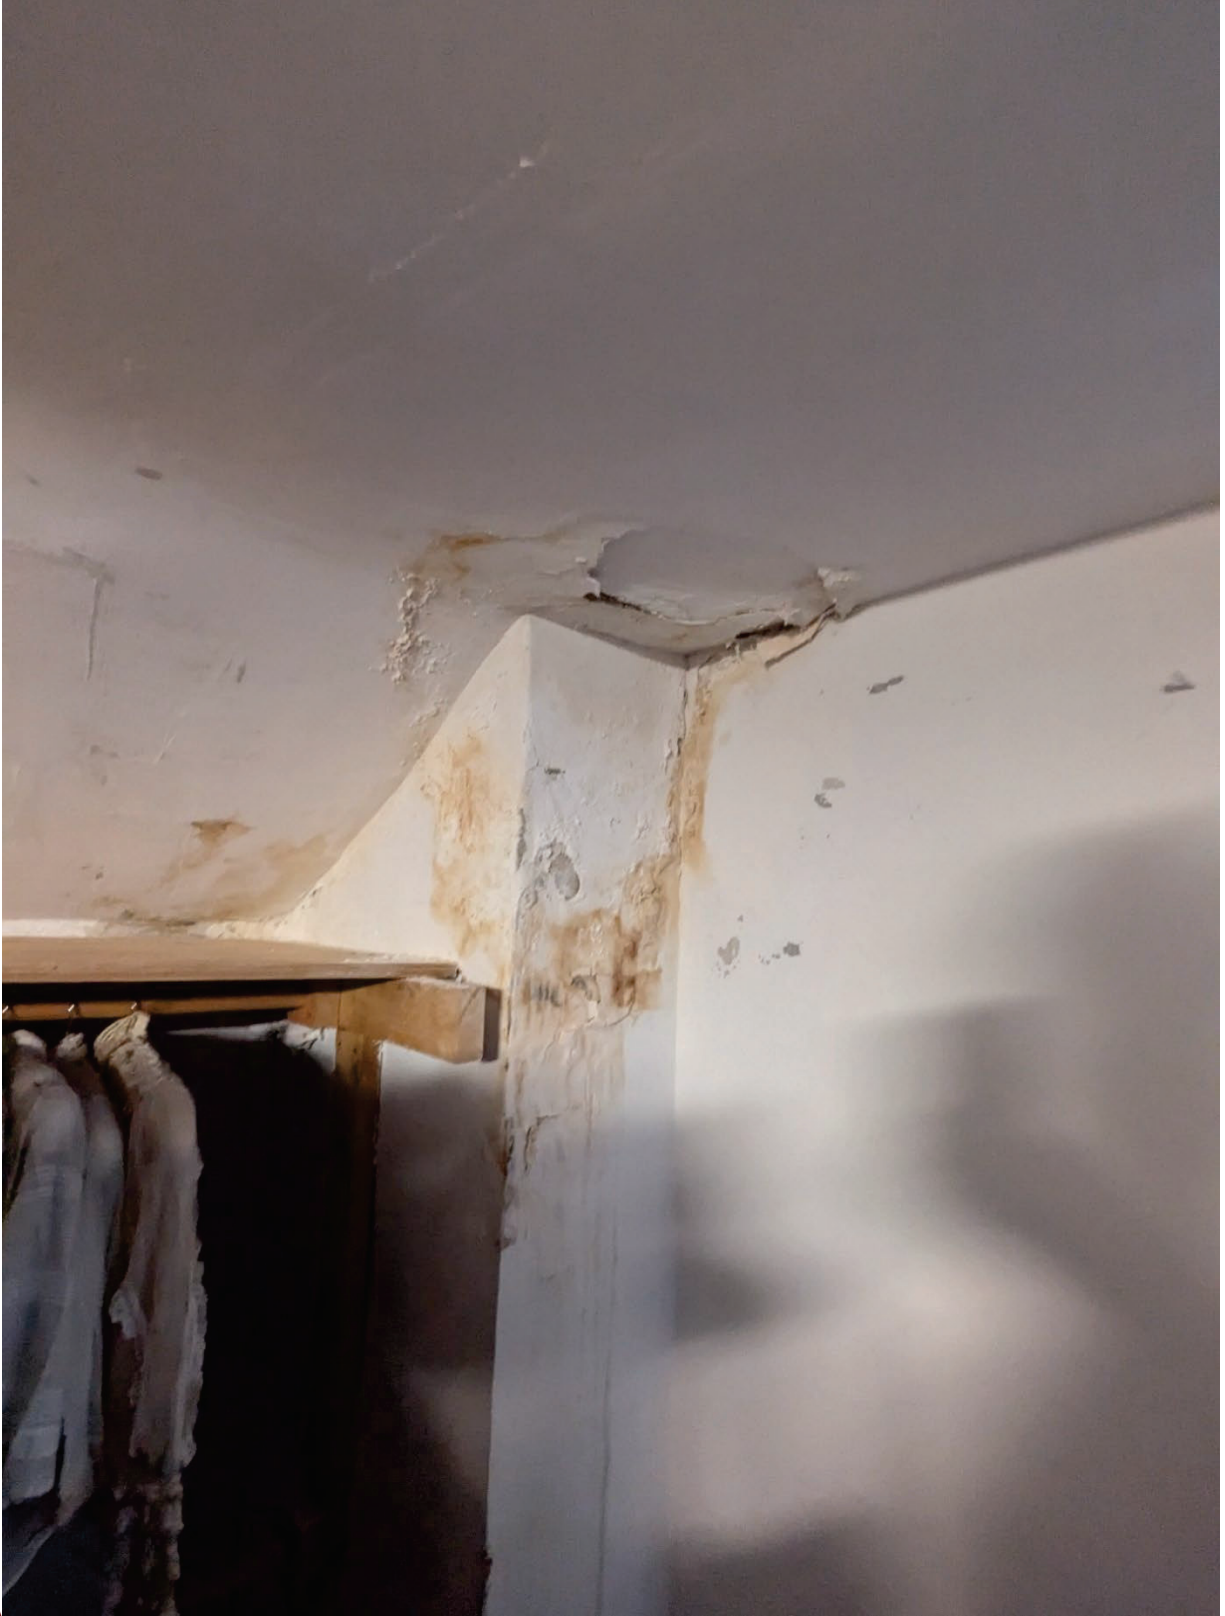
Figure A-21. Example of interior water damage, western room, third floor, 2024.

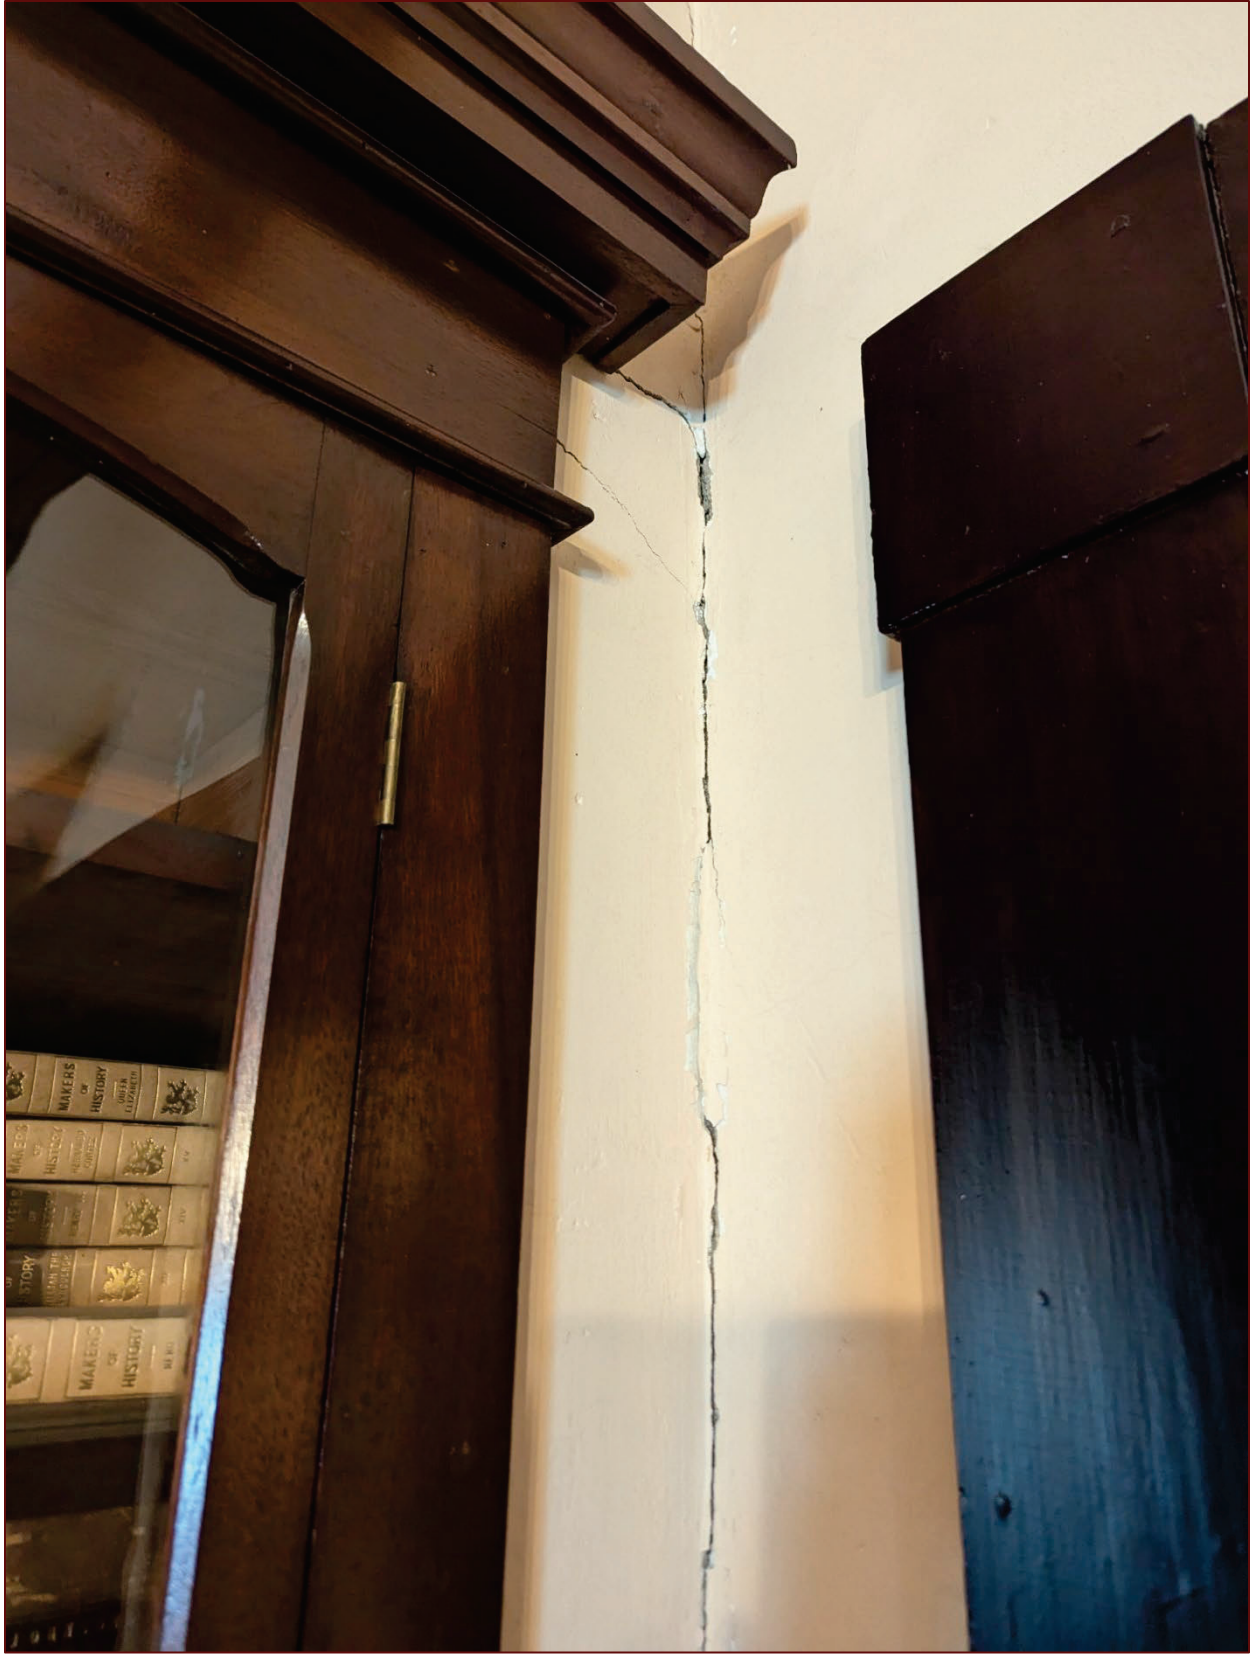
Figure A-22. Example of interior plaster cracking, southwest corner room, first floor, 2024.

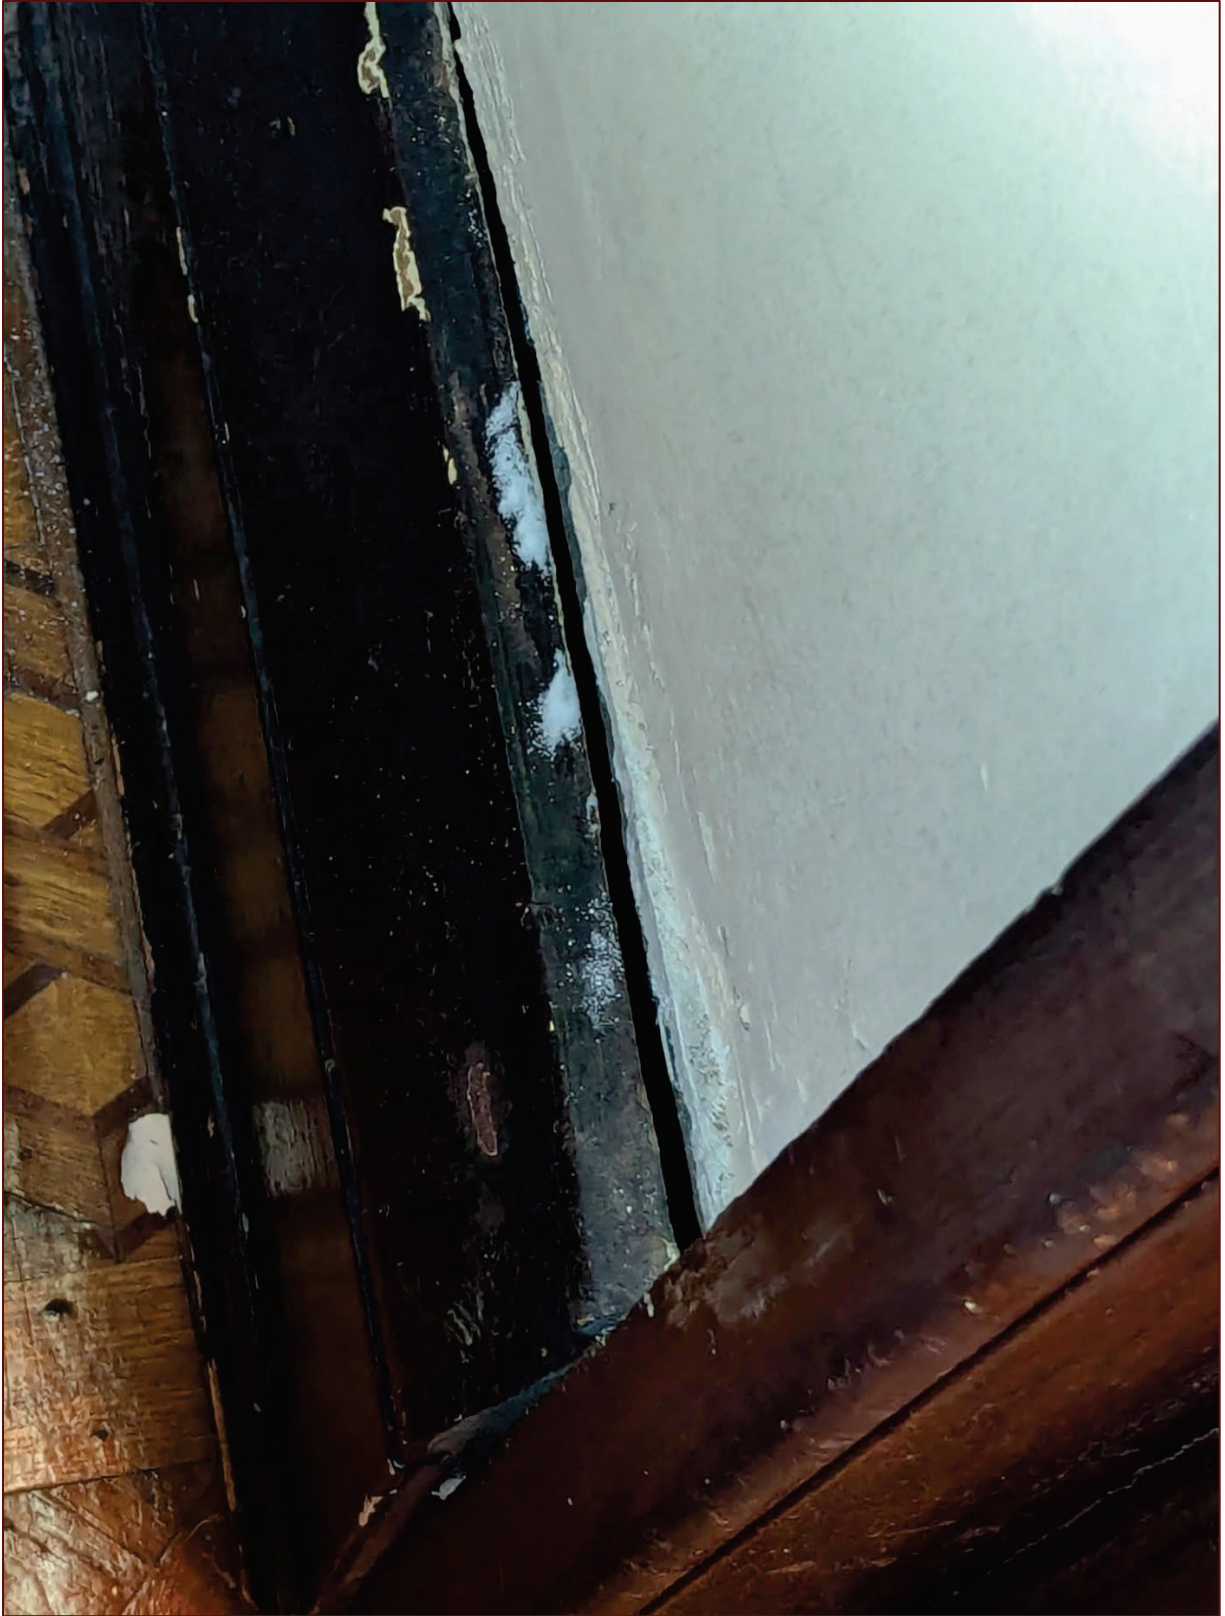
Figure A-23. Example of baseboard/wall separation, southwest corner room, first floor, 2024.

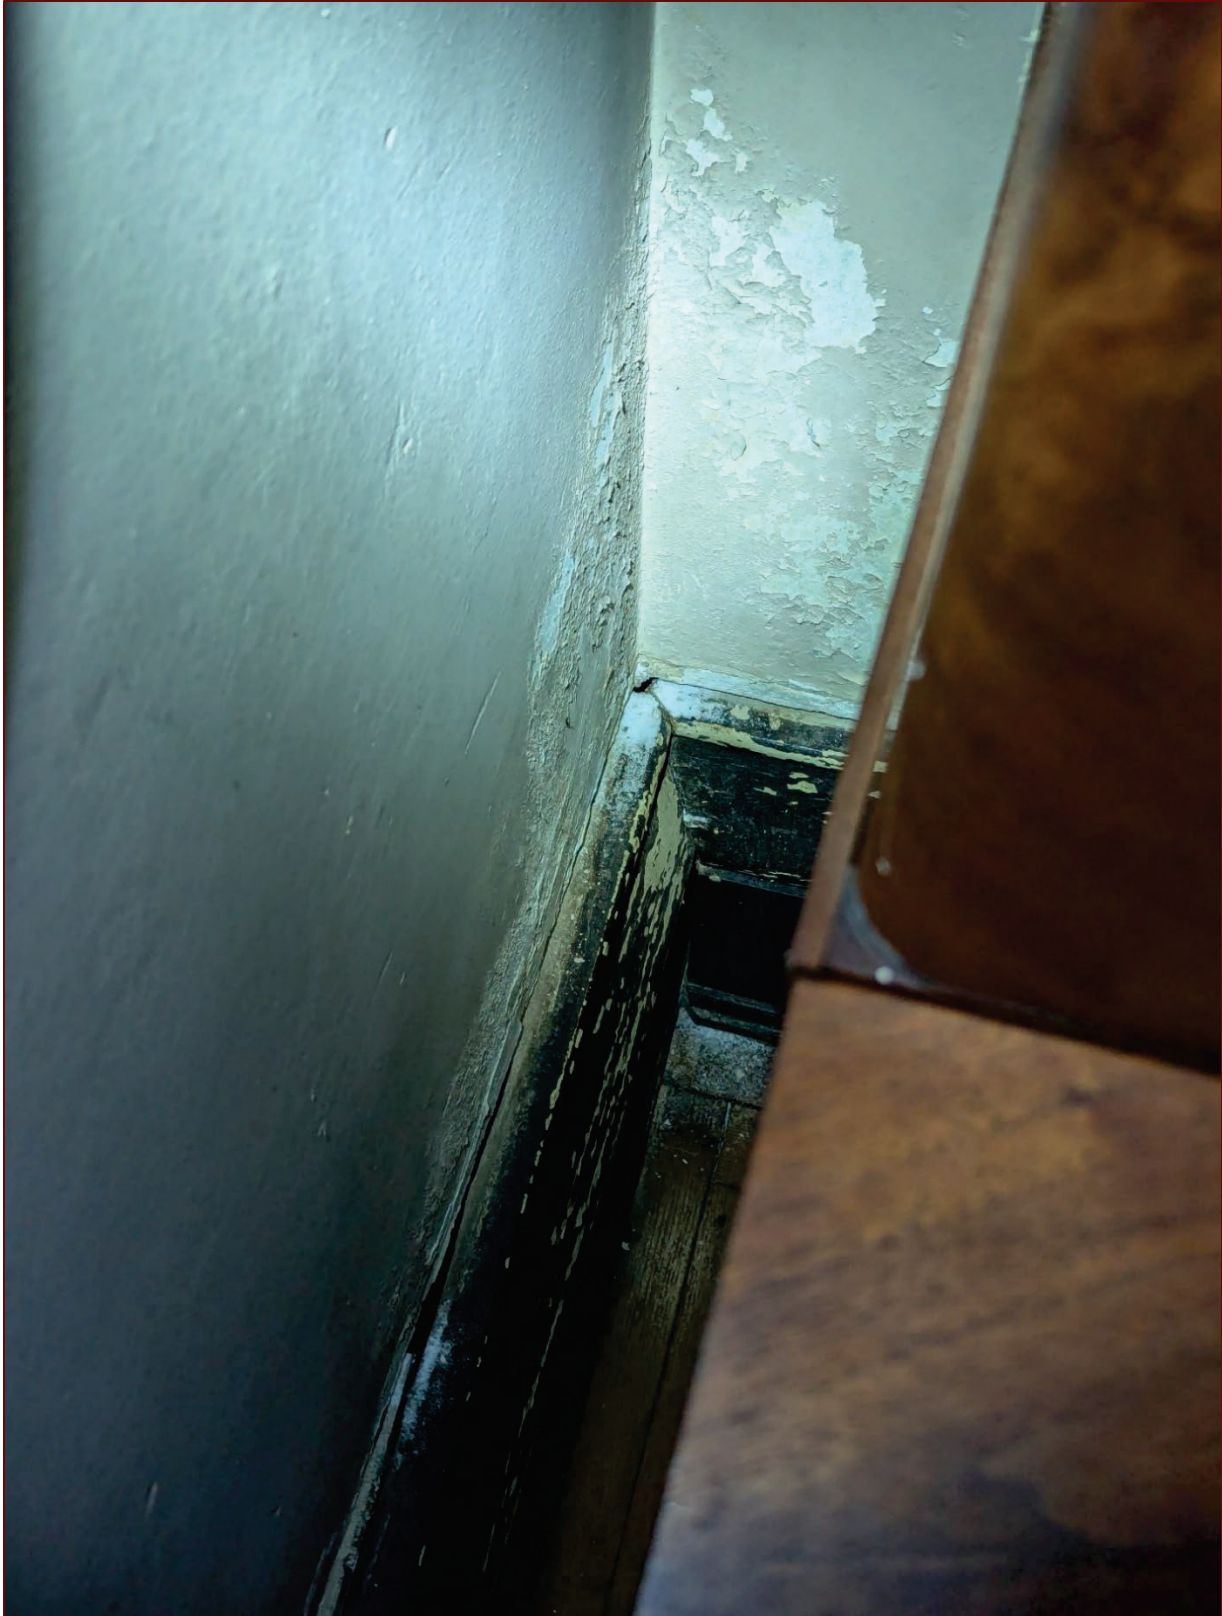
Figure A-25. Example of paint/plaster delamination and cracking, possible humidity issue, 2024.

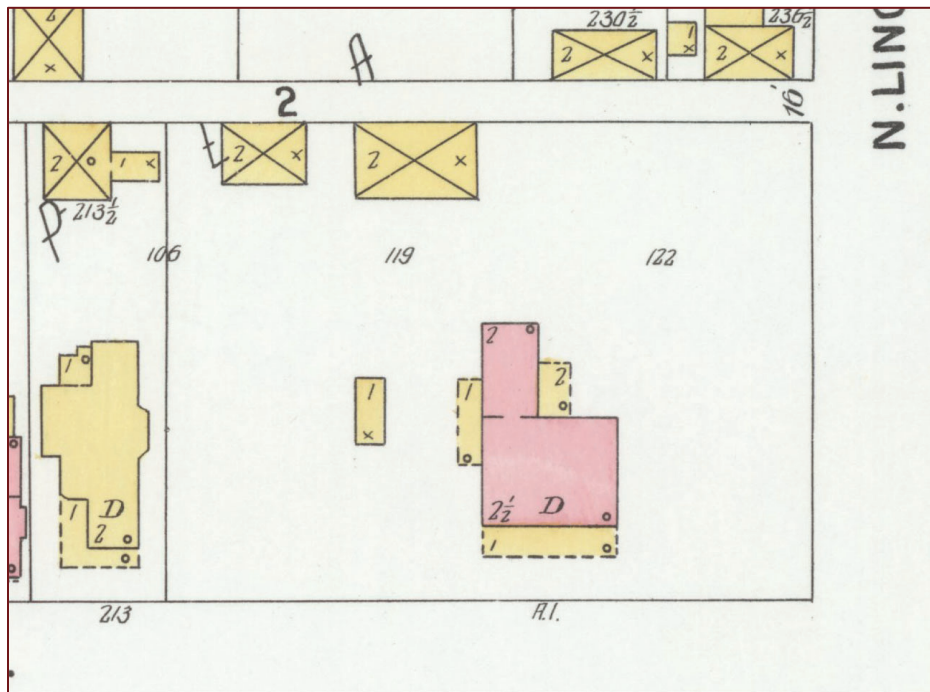
Figure 8-1 1900 Sanborn Map showing Rombach Place (Sanborn Fire Insurance Company 1900)

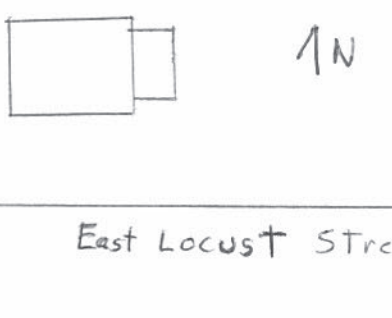
19. Architect or Engineer	31. Wall Construction Brick Stucco Overlay
