*Preservation Maintenance
Plan Report for the
Clinton County Historical
Society/Rombach Place
Carriage House*

Project No. 24-100901.002

Preservation Maintenance Plan Report Clinton County Historical Society/Rombach Place Carriage House

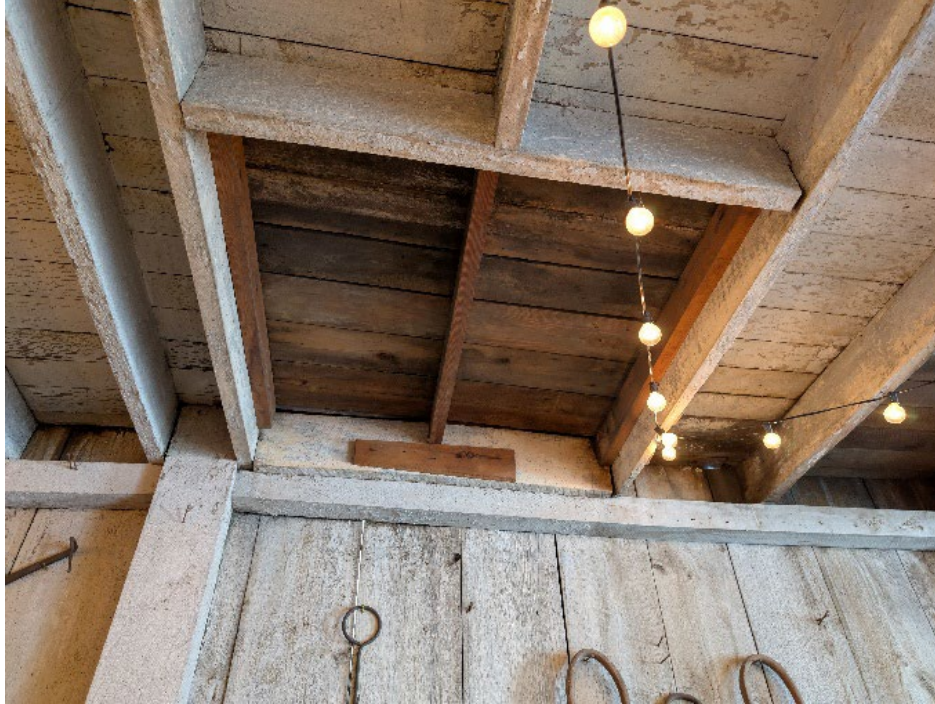
supporting one of two tie beams, the second tie beam runs through the center of the room. A previously enclosed hay drop sits in the center of the stalls (Figure 4-8).

Figure 4-8 Enclosed former hay drop, 2025
